Access Compliance Report

Public Rights-of-Way

(Curb Ramps)

Intersection ID: 10570	Main Street: HERRIN_AV	Cross Street: HOLT_ST	Location: SW
ADA ID: 5733C57A46CC	Ramp Type: BlendTrans1	Initial Pass/Fail: Fail	Overall Compliance: No
Codes/Mitigation Info/Possible Solution		Field Measurements/Component Compliance	
Severity Score: 8.75

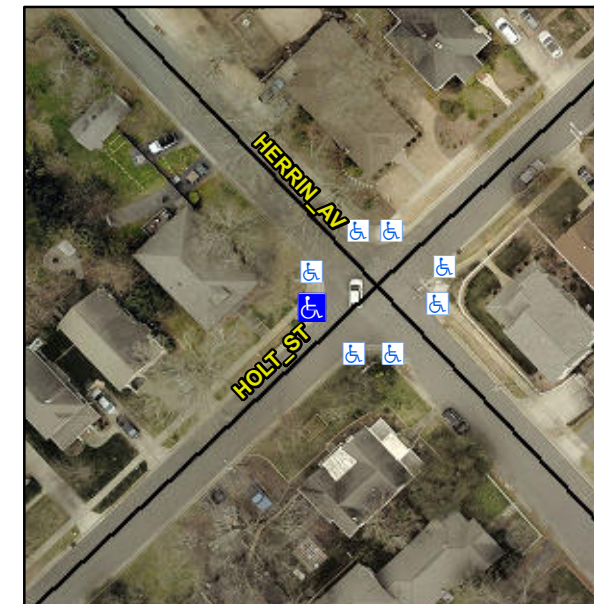
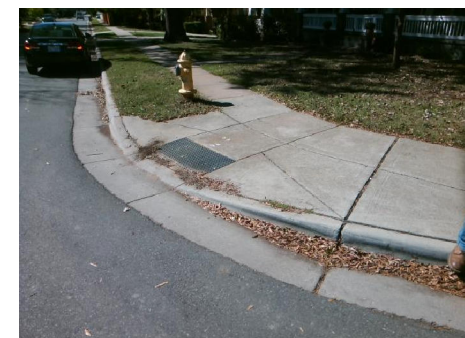
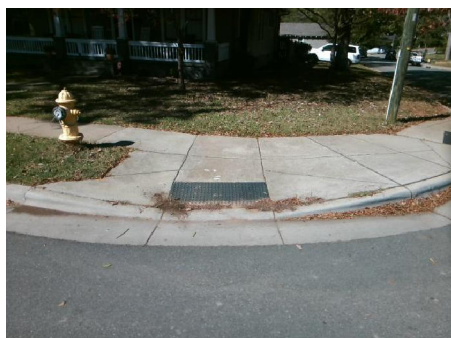
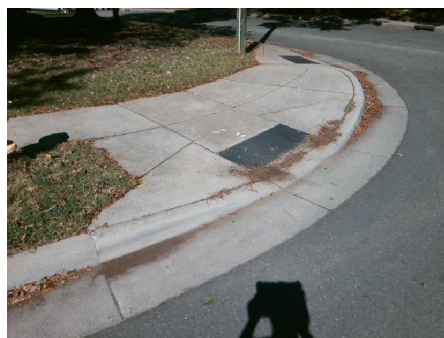
Not Found, R304.5.1

Compliance	Description	Data	Compliance	Description	Data
N/A	Ramp Length (in)	59.0	Yes	BlendTrans Slope (%)	4.8
No	Ramp Width (in)	45.0	Yes	BlendTrans XSlope (%)	0.7
N/A	Flare Type LT	N/A	N/A	Flare Type RT	N/A
N/A	Flare Slope LT (%)	N/A	N/A	Flare Slope RT (%)	N/A
N/A	Flare Traversable LT?	N/A	N/A	Flare Traversable RT?	N/A
N/A	Landing Length (in)	N/A	N/A	DWS Provided?	N/A
N/A	Landing Width (in)	N/A	N/A	DWS Contrast?	N/A
N/A	Landing Slope (%)	N/A	N/A	DWS Length (in)	N/A
N/A	Landing X Slope (%)	N/A	N/A	DWS Full Width?	N/A
N/A	Landing Curb? (Y/N)	N/A	N/A	DWS Offset (in)	N/A
N/A	Shared Landing?	N/A			
N/A	Gutter Ponding?	N/A	N/A	Gutter Slope (%)	N/A
N/A	Gutter Lip Ht (in)	N/A	N/A	Gutter X Slope (%)	N/A
N/A	Painted X Walk1?	No	N/A	Painted X Walk2?	N/A
	X Walk 1 Direction	To SE		X Walk 2 Direction	N/A
	X Walk 1 Width (in)	N/A		X Walk 2 Width (in)	N/A
	X Walk 1 Slope (%)	3.5		X Walk 2 Slope (%)	N/A
	X Walk 1 X Slope (%)	1.5		X Walk 2 X Slope (%)	N/A

N/A	Ramp inside XWalk1?	N/A	N/A	Ramp inside XWalk2?	N/A
	Road Slope (%)	1.5		Clear Space?	N/A
	Road X Slope (%)	3.5	N/A	Clear Space to XWalk (in)	N/A
N/A	Any Obstructions?	N/A	N/A	Storm Grate/Utility Hazard?	N/A
	Obstruction Type			Storm Grate/Utility Type	
		N/A			N/A
			Yes	Surface Condition? (G/P)	Good
			No	Curb Slope (%)	11.6

Remove & Replace Curb Ramp With Two New Directional Ramps or Equivalent.

Total Cost: \$ 3200.00
