## Access Compliance Report Public Rights-of-Way (Curb Ramps)

Intersection ID: 9770 Main Street: DEMILL_LN			Cross Street: E_W_T_HARRIS_BV					Location:	NE
ADA ID: 574EAF4CE127 Ramp Type: PerpD		/pe: PerpDiag	Initial Pass/Fail: Fail Overall Compliance: No				o Severity Score:	22.5	
Codes/Mitigation Info/Possible Solution				Field Measurements/Component Compliance					
		Possible Solutions:		Compliance Description Da			ta Compliance Description		Data
		Remove & Replace Curb Ramp	With	N/A	Ramp Length (in)	60.5	No	Ramp Slope (%)	10.5
		Two New Directional Ramps or Equivalent. Surveyor Notes: N/A		No	Ramp Width (in)	43.0	No	Ramp XSlope (%)	4.4
				N/A	Flare Type LT	N/A	N/A	Flare Type RT	N/A
				N/A	Flare Slope LT (%)	N/A	N/A	Flare Slope RT (%)	N/A
				N/A	Flare Traversable LT?	N/A	N/A	Flare Traversable RT?	N/A
				N/A	Landing Length (in)	N/A	N/A	DWS Provided?	N/A
				N/A	Landing Width (in)	N/A	N/A	DWS Contrast?	N/A
<u>5</u> <u>5</u>				N/A	Landing Slope (%)	N/A	N/A	DWS Length (in)	N/A

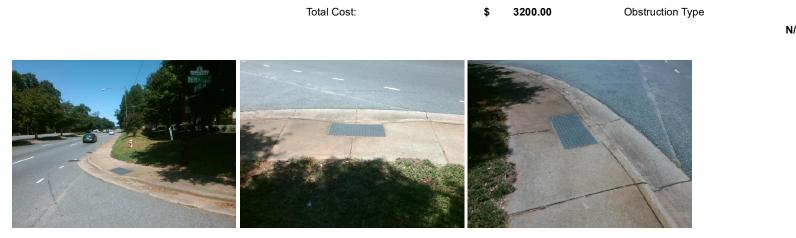
N/A	Landing X Slope (%)	N/A	N/A	DWS Full Width?	N/A
	And a state of the			N/A	Landing Curb? (Y/N)	N/A	N/A	DWS Offset (in)	N/A
				N/A	Shared Landing?	N/A			
		PROW/ADA:		N/A	Gutter Ponding?	N/A	N/A	Gutter Slope (%)	N/A
	and the second se	Not Found, R304.5.1, R304.2.2,		N/A	Gutter Lip Ht (in)	0.5	N/A	Gutter X Slope (%)	N/A
	R304.5.3		N/A	Painted X Walk1?	No	N/A	Painted X Walk2?	No	
	CE Side				X Walk 1 Direction	To W		X Walk 2 Direction	To S
				N/A	X Walk 1 Width (in)	N/A	N/A	X Walk 2 Width (in)	N/A
Street 1 Name	E W T HARRIS BV				X Walk 1 Slope (%)	0.5		X Walk 2 Slope (%)	2.5
Stop Condition-Street 2	None				X Walk 1 X Slope (%)	0.8		X Walk 2 X Slope (%)	4.9
Street 2 Name	DEMILL LN			N/A	Ramp inside XWalk1?	N/A	N/A	Ramp inside XWalk2?	N/A
Stop Condition-Street 1	StopSign				Road Slope (%)	0.4	N/A	Clear Space?	N/A
					Road X Slope (%)	8.4	N/A	Clear Space to XWalk (in)	N/A
				N/A	Any Obstructions?	N/A	N/A	Storm Grate/Utility Hazard?	N/A

**Yes** Surface Condition? (G/P)

Good

Total Cost: \$	3200.00		Obstruction Type			Storm Grate/Utility Type	
						N/A			N/A
