Access Compliance Report Public Rights-of-Way (Curb Ramps)

Intersection ID: 53147 Main Street: ACHIEVEMENT LN Cross Street: NEW_RENAISSANCE_WY Location: SW ADA ID: 575179630DC3 Ramp Type: Directional1 Initial Pass/Fail: Fail **Overall Compliance: No Severity Score:** 12.5

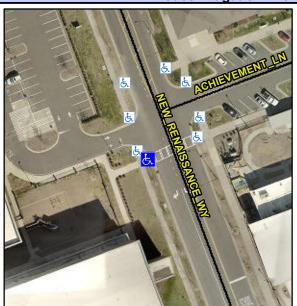
Possible Solution		Field Measurements/Component Compliance				
Possible Solutions:		Compliance Description		Compliance Description		
Remove & Replace Entire Ramp.	N/A	Ramp Length (in)	66.0	N/A	Grade Break?	
·	Yes	Ramp Width (in)	70.0	N/A	Grade Break Slope (%)	
	Yes	Ramp Slope (%)	7.5	N/A	Grade Break XSlope (%)	
	No	Ramp XSlope (%)	6.2			
	N/A	Flare Type LT	N/A	N/A	Flare Type RT	
	N/A	Flare Slope LT (%)	N/A	N/A	Flare Slope RT (%)	
Surveyor Notes:	N/A	Flare Traversable LT?	N/A	N/A	Flare Traversable RT?	
N/A	N/A	Landing Length (in)	0.0	N/A	DWS Provided?	
	N/A	Landing Width (in)	0.0	N/A	DWS Contrast?	
	N/A	Landing Slope (%)	0.0	N/A	DWS Length (in)	
	N/A	Landing X Slope (%)	0.0	N/A	DWS Full Width?	
PROW/ADA:	N/A	Landing Curb? (Y/N)	N/A	N/A	DWS Offset LT (in)	
R304.5.3	N/A	Shared Landing?	N/A	N/A	DWS Offset RT (in)	
	N/A	Gutter Ponding?	0.0	N/A	Gutter Slope (%)	
	N/A	Gutter Lip Ht (in)	0.0	N/A	Gutter X Slope (%)

N/A	Painted X Walk1?	No		Road Slope (%)	
		X Walk 1 Direction	To NE		Road X Slope (%)	
		X Walk 1 Width (in)	N/A	l	Clear Space?	
		X Walk 1 Slope (%)	2.9	N/A	Clear Space to XWalk (in)	
		X Walk 1 X Slope (%)	0.4	N/A	Storm Grate/Utility Hazard?	
	N/A	Ramp inside XWalk1?	N/A		Storm Grate/Utility Type	
	N/A	Any Obstructions?	N/A
