Access Compliance Report

Public Rights-of-Way

(Curb Ramps)

Intersection ID: N/A	Main Street: TWITTER_LN	Cross Street: ROCKY_RIVER_RD	Location: NE
ADA ID: 575D2542EDB9	Ramp Type: Para	Initial Pass/Fail: Fail	Overall Compliance: No
Codes/Mitigation Info/Possible Solution		Field Measurements/Component Compliance

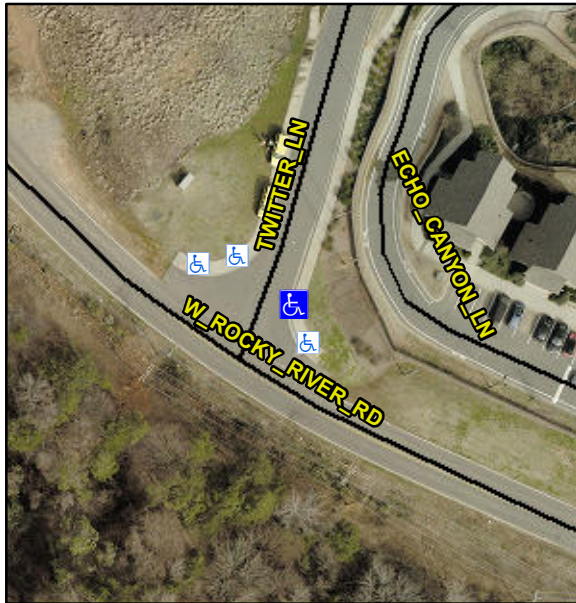
R304.5.3, R304.3.2

Compliance	Description	Data	Compliance	Description	Data
N/A	Ramp Length LT (in)	57.0	N/A	Ramp Length RT (in)	55.0
Yes	Ramp Width LT (in)	59.0	Yes	Ramp Width RT (in)	60.0
Yes	Ramp Slope LT (%)	5.9	No	Ramp Slope RT (%)	9.1
No	Ramp XSlope LT (%)	2.4	Yes	Ramp XSlope RT (%)	1.2
N/A	Landing Length (in)	N/A	N/A	DWS Provided?	N/A
N/A	Landing Width (in)	N/A	N/A	DWS Contrast?	N/A
N/A	Landing Slope (%)	N/A	N/A	DWS Length (in)	N/A
N/A	Landing X Slope (%)	N/A	N/A	DWS Full Width?	N/A
N/A	Landing Curb? (Y/N)	N/A	N/A	DWS Offset (in)	N/A
N/A	Shared Landing?	N/A			
N/A	Gutter Ponding?	N/A	N/A	Gutter Slope (%)	N/A
N/A	Gutter Lip Ht (in)	N/A	N/A	Gutter X Slope (%)	N/A
N/A	Painted X Walk1?	No	N/A	Painted X Walk2?	N/A
	X Walk 1 Direction	To W		X Walk 2 Direction	N/A
N/A	X Walk 1 Width (in)	N/A	N/A	X Walk 2 Width (in)	N/A
	X Walk 1 Slope (%)	3.0		X Walk 2 Slope (%)	N/A
	X Walk 1 X Slope (%)	1.6		X Walk 2 X Slope (%)	N/A
N/A	Ramp inside XWalk1?	N/A	N/A	Ramp inside XWalk2?	N/A

Road Slope (%)	N/A	N/A	Clear Space?	N/A
	Road X Slope (%)	N/A	N/A	Clear Space to XWalk (in)	N/A
N/A	Any Obstructions?	N/A	N/A	Storm Grate/Utility Hazard?	N/A
	Obstruction Type			Storm Grate/Utility Type	
		N/A			N/A
			Yes	Surface Condition? (G/P)	Good
			N/A	Curb Slope (%)	1.2

Remove & Replace Entire Ramp.
