# Access Compliance Report

## Public Rights-of-Way

### (Curb Ramps)

Intersection ID: 4508	Main Street: NORCROFT_DR	Cross Street: W_W_T_HARRIS_BV	Location: W
ADA ID: 576540B5F1A8	Ramp Type: Perp	Initial Pass/Fail: Fail	Overall Compliance: No
Severity Score: 33.75			
Codes/Mitigation Info/Possible Solution		Field Measurements/Component Compliance

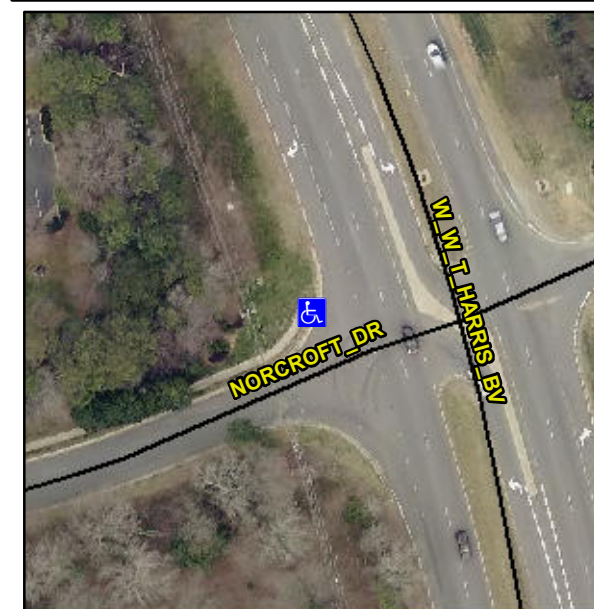
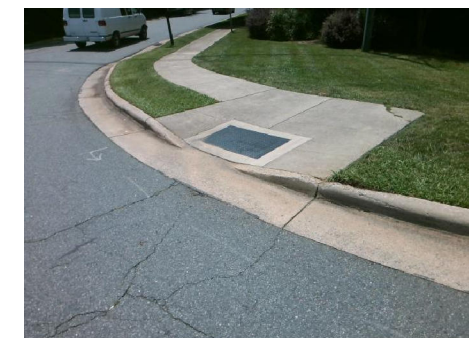
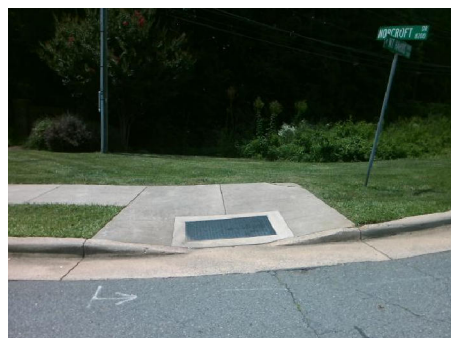
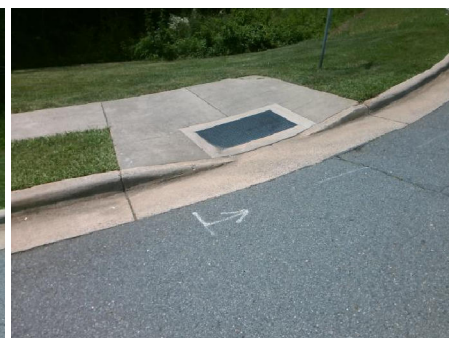
**Not Found, R304.5.1, R304.5.3**

Compliance	Description	Data	Compliance	Description	Data
N/A	Ramp Length (in)	49.5	Yes	Ramp Slope (%)	5.0
No	Ramp Width (in)	42.0	No	Ramp XSlope (%)	11.7
N/A	Flare Type LT	N/A	N/A	Flare Type RT	N/A
N/A	Flare Slope LT (%)	N/A	N/A	Flare Slope RT (%)	N/A
N/A	Flare Traversable LT?	N/A	N/A	Flare Traversable RT?	N/A
N/A	Landing Length (in)	N/A	N/A	DWS Provided?	N/A
N/A	Landing Width (in)	N/A	N/A	DWS Contrast?	N/A
N/A	Landing Slope (%)	N/A	N/A	DWS Length (in)	N/A
N/A	Landing X Slope (%)	N/A	N/A	DWS Full Width?	N/A
N/A	Landing Curb? (Y/N)	N/A	N/A	DWS Offset (in)	N/A
N/A	Shared Landing?	N/A			
N/A	Gutter Ponding?	N/A	N/A	Gutter Slope (%)	N/A
N/A	Gutter Lip Ht (in)	N/A	N/A	Gutter X Slope (%)	N/A
N/A	Painted X Walk1?	No	N/A	Painted X Walk2?	N/A
	X Walk 1 Direction	To E		X Walk 2 Direction	N/A
N/A	X Walk 1 Width (in)	N/A	N/A	X Walk 2 Width (in)	N/A
	X Walk 1 Slope (%)	2.8		X Walk 2 Slope (%)	N/A
	X Walk 1 X Slope (%)	11.8		X Walk 2 X Slope (%)	N/A

N/A	Ramp inside XWalk1?	N/A	N/A	Ramp inside XWalk2?	N/A
	Road Slope (%)	N/A	N/A	Clear Space?	N/A
	Road X Slope (%)	N/A	N/A	Clear Space to XWalk (in)	N/A
N/A	Any Obstructions?	N/A	N/A	Storm Grate/Utility Hazard?	N/A
	Obstruction Type			Storm Grate/Utility Type	
		N/A			N/A
			Yes	Surface Condition? (G/P)	Good

**Remove & Replace Entire Ramp.**

Total Cost: \$ 1850.00
