Access Compliance Report

Public Rights-of-Way

Intersection ID: 6967	Main Street: DAYBREAK_DR	Cross Street: ONEIDA_RD	Location:	SE
ADA ID: 57672C2DFCD5	Ramp Type: PerpDiag	Initial Pass/Fail: Fail	Overall Compliance: No	Severity Score: 10
Codes/Mitigation Info/Possible Solution		Field Measurements/Component Compliance

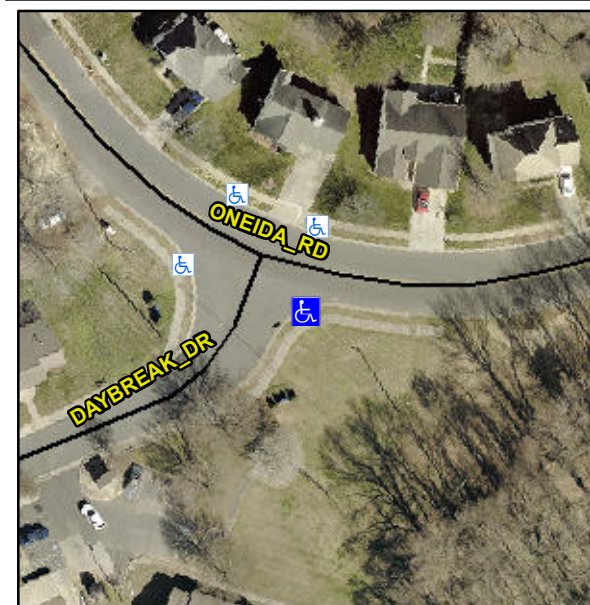
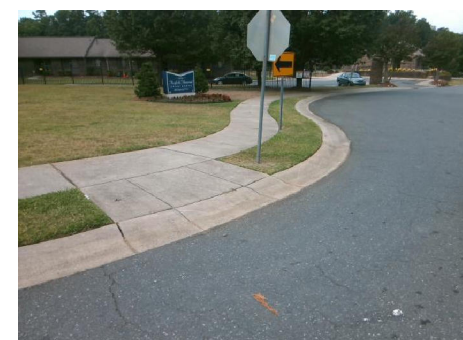
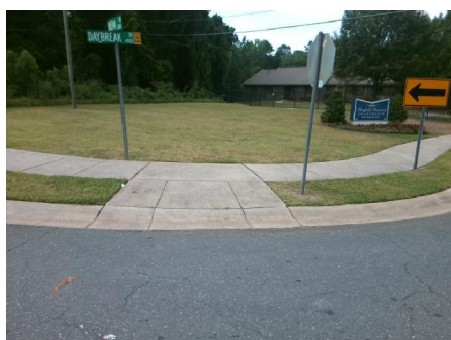
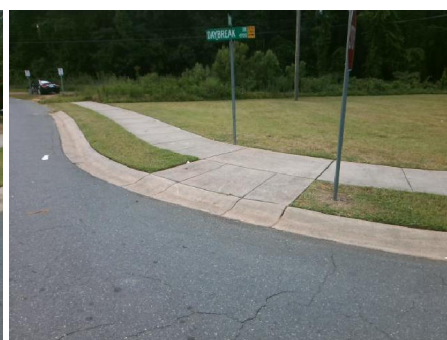
Not Found, R304.5.1, R304.5.3

Compliance	Description	Data	Compliance	Description	Data
N/A	Ramp Length (in)	51.0	Yes	Ramp Slope (%)	6.0
No	Ramp Width (in)	42.0	No	Ramp XSlope (%)	3.9
N/A	Flare Type LT	N/A	N/A	Flare Type RT	N/A
N/A	Flare Slope LT (%)	N/A	N/A	Flare Slope RT (%)	N/A
N/A	Flare Traversable LT?	N/A	N/A	Flare Traversable RT?	N/A
N/A	Landing Length (in)	N/A	N/A	DWS Provided?	N/A
N/A	Landing Width (in)	N/A	N/A	DWS Contrast?	N/A
N/A	Landing Slope (%)	N/A	N/A	DWS Length (in)	N/A
N/A	Landing X Slope (%)	N/A	N/A	DWS Full Width?	N/A
N/A	Landing Curb? (Y/N)	N/A	N/A	DWS Offset (in)	N/A
N/A	Shared Landing?	N/A			
N/A	Gutter Ponding?	N/A	N/A	Gutter Slope (%)	N/A
N/A	Gutter Lip Ht (in)	N/A	N/A	Gutter X Slope (%)	N/A
N/A	Painted X Walk1?	No	N/A	Painted X Walk2?	No
	X Walk 1 Direction	To N		X Walk 2 Direction	To NW
N/A	X Walk 1 Width (in)	N/A	N/A	X Walk 2 Width (in)	N/A
	X Walk 1 Slope (%)	5.3		X Walk 2 Slope (%)	2.6
	X Walk 1 X Slope (%)	0.4		X Walk 2 X Slope (%)	4.7

N/A	Ramp inside XWalk1?	N/A	N/A	Ramp inside XWalk2?	N/A
	Road Slope (%)	3.3	N/A	Clear Space?	N/A
	Road X Slope (%)	0.8	N/A	Clear Space to XWalk (in)	N/A
N/A	Any Obstructions?	N/A	N/A	Storm Grate/Utility Hazard?	N/A
	Obstruction Type			Storm Grate/Utility Type	
		N/A			N/A
			Yes	Surface Condition? (G/P)	Good

Remove & Replace Curb Ramp With Two New Directional Ramps or Equivalent.
