# Access Compliance Report

## Public Rights-of-Way

### (Curb Ramps)

Intersection ID: 15160	Main Street: GRIFFITH_ST	Cross Street: S_TRYON_ST	Location: SW
ADA ID: 576B087FAC83	Ramp Type: Perp	Initial Pass/Fail: Fail	Overall Compliance: No
		Severity Score: 10

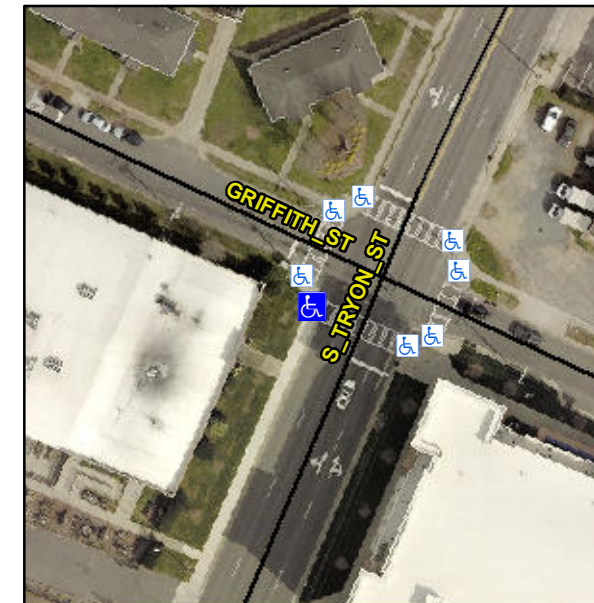
**Not Found, R304.5.1, R304.5.3**

Compliance	Description	Data	Compliance	Description	Data
N/A	Ramp Length (in)	62.0	Yes	Ramp Slope (%)	7.3
No	Ramp Width (in)	47.0	No	Ramp XSlope (%)	3.8
N/A	Flare Type LT	N/A	N/A	Flare Type RT	N/A
N/A	Flare Slope LT (%)	N/A	N/A	Flare Slope RT (%)	N/A
N/A	Flare Traversable LT?	N/A	N/A	Flare Traversable RT?	N/A
N/A	Landing Length (in)	N/A	N/A	DWS Provided?	N/A
N/A	Landing Width (in)	N/A	N/A	DWS Contrast?	N/A
N/A	Landing Slope (%)	N/A	N/A	DWS Length (in)	N/A
N/A	Landing X Slope (%)	N/A	N/A	DWS Full Width?	N/A
N/A	Landing Curb? (Y/N)	N/A	N/A	DWS Offset (in)	N/A
N/A	Shared Landing?	N/A			
N/A	Gutter Ponding?	N/A	N/A	Gutter Slope (%)	N/A
N/A	Gutter Lip Ht (in)	N/A	N/A	Gutter X Slope (%)	N/A
N/A	Painted X Walk1?	Yes	N/A	Painted X Walk2?	N/A
	X Walk 1 Direction	To SE		X Walk 2 Direction	N/A
N/A	X Walk 1 Width (in)	115.0	N/A	X Walk 2 Width (in)	N/A
	X Walk 1 Slope (%)	1.8		X Walk 2 Slope (%)	N/A
	X Walk 1 X Slope (%)	1.5		X Walk 2 X Slope (%)	N/A

N/A	Ramp inside XWalk1?	Yes	N/A	Ramp inside XWalk2?	N/A
	Road Slope (%)	N/A	N/A	Clear Space?	N/A
	Road X Slope (%)	N/A	N/A	Clear Space to XWalk (in)	N/A
N/A	Any Obstructions?	N/A	N/A	Storm Grate/Utility Hazard?	N/A
	Obstruction Type			Storm Grate/Utility Type	
		N/A			N/A
		Yes		Surface Condition? (G/P)	Good

**Remove & Replace Entire Ramp.**

Total Cost: \$ 1850.00
