## **Access Compliance Report Public Rights-of-Way** (Curb Ramps)

Intersection ID: 3050 Main Street: SIX POINT LN Cross Street: HARTINGTON PL Location: SW Initial Pass/Fail: Fail **Overall Compliance: No Severity Score:** ADA ID: 576B1FAB7510 Ramp Type: Perp 8.75

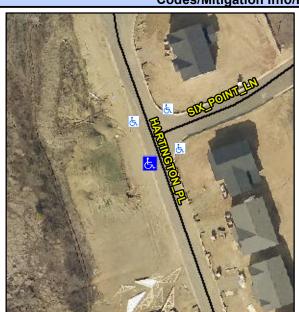
Possible Solutions: Compliance Description N/A Remove & Replace Entire Ramp. No N/A N/A N/A N/A Surveyor Notes: N/A N/A N/A N/A N/A N/A PROW/ADA: N/A Not Found, R304.5.1 N/A N/A N/A N/A
