Access Compliance Report

Public Rights-of-Way

(Curb Ramps)

Intersection ID: 12519	Main Street: E_6TH_ST	Cross Street: N_CALDWELL_ST	Location: E
ADA ID: 578346F68148	Ramp Type: Perp	Initial Pass/Fail: Fail	Overall Compliance: No
			Severity Score: 21.25

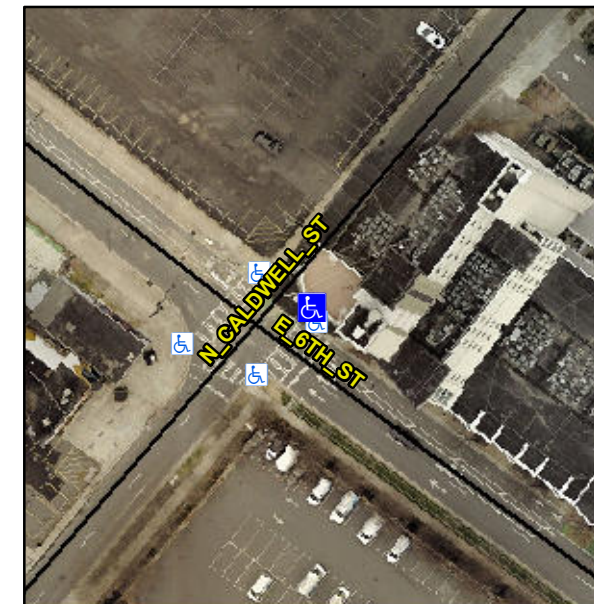
Not Found, R304.5.1, R304.2.2

Compliance	Description	Data	Compliance	Description	Data
N/A	Ramp Length (in)	70.0	No	Ramp Slope (%)	8.8
No	Ramp Width (in)	47.0	Yes	Ramp XSlope (%)	0.8
N/A	Flare Type LT	N/A	N/A	Flare Type RT	N/A
N/A	Flare Slope LT (%)	N/A	N/A	Flare Slope RT (%)	N/A
N/A	Flare Traversable LT?	N/A	N/A	Flare Traversable RT?	N/A
N/A	Landing Length (in)	N/A	N/A	DWS Provided?	N/A
N/A	Landing Width (in)	N/A	N/A	DWS Contrast?	N/A
N/A	Landing Slope (%)	N/A	N/A	DWS Length (in)	N/A
N/A	Landing X Slope (%)	N/A	N/A	DWS Full Width?	N/A
N/A	Landing Curb? (Y/N)	N/A	N/A	DWS Offset (in)	N/A
N/A	Shared Landing?	N/A			
N/A	Gutter Ponding?	N/A	N/A	Gutter Slope (%)	N/A
N/A	Gutter Lip Ht (in)	N/A	N/A	Gutter X Slope (%)	N/A
N/A	Painted X Walk1?	Yes	N/A	Painted X Walk2?	N/A
	X Walk 1 Direction	To NW		X Walk 2 Direction	N/A
N/A	X Walk 1 Width (in)	110.0	N/A	X Walk 2 Width (in)	N/A
	X Walk 1 Slope (%)	3.7		X Walk 2 Slope (%)	N/A
	X Walk 1 X Slope (%)	5.6		X Walk 2 X Slope (%)	N/A

Possible Solutions:

Remove & Replace Entire Ramp.
