Access Compliance Report

Public Rights-of-Way

(Curb Ramps)

Intersection ID: 26208	Main Street: BALLANTRAE VILLAGE DR	Cross Street: ELM LN	Location: NE
ADA ID: 5783A4BF2319	Ramp Type: MedianPerp	Initial Pass/Fail: Fail	Overall Compliance: No
Severity Score: 33.75			
Codes/Mitigation Info/Possible Solution		Field Measurements/Component Compliance

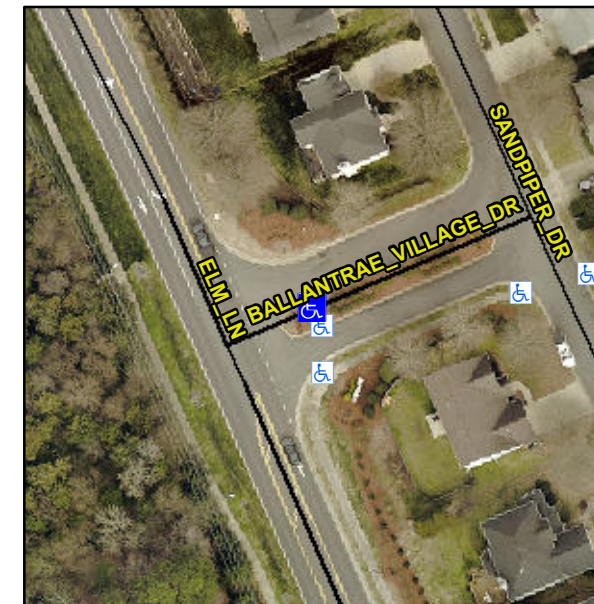
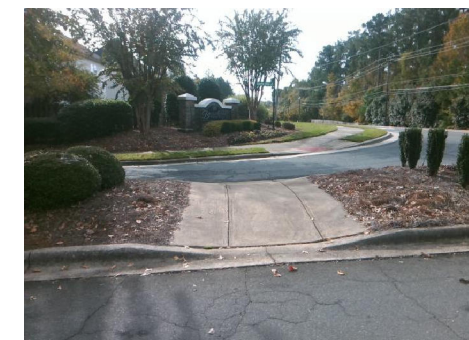
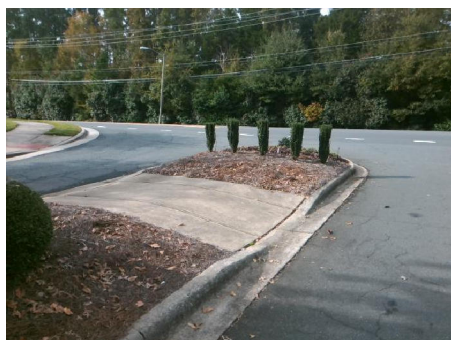
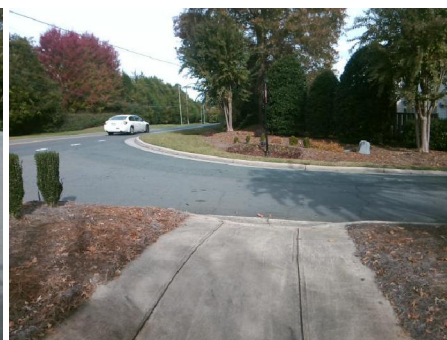
Not Found, R304.5.1, R304.2.2, R304.5.3

Compliance	Description	Data	Compliance	Description	Data
N/A	Ramp Length (in)	70.0	No	Ramp Slope (%)	10.0
No	Ramp Width (in)	44.5	No	Ramp XSlope (%)	6.8
N/A	Flare Type LT	N/A	N/A	Flare Type RT	N/A
N/A	Flare Slope LT (%)	N/A	N/A	Flare Slope RT (%)	N/A
N/A	Flare Traversable LT?	N/A	N/A	Flare Traversable RT?	N/A
N/A	Landing Length (in)	N/A	N/A	DWS Provided?	N/A
N/A	Landing Width (in)	N/A	N/A	DWS Contrast?	N/A
N/A	Landing Slope (%)	N/A	N/A	DWS Length (in)	N/A
N/A	Landing X Slope (%)	N/A	N/A	DWS Full Width?	N/A
N/A	Landing Curb? (Y/N)	N/A	N/A	DWS Offset (in)	N/A
N/A	Shared Landing?	N/A			
N/A	Gutter Ponding?	N/A	N/A	Gutter Slope (%)	N/A
N/A	Gutter Lip Ht (in)	N/A	N/A	Gutter X Slope (%)	N/A
N/A	Painted X Walk1?	No	N/A	Painted X Walk2?	N/A
	X Walk 1 Direction	To N		X Walk 2 Direction	N/A
N/A	X Walk 1 Width (in)	N/A	N/A	X Walk 2 Width (in)	N/A
	X Walk 1 Slope (%)	0.8		X Walk 2 Slope (%)	N/A
	X Walk 1 X Slope (%)	7.5		X Walk 2 X Slope (%)	N/A

N/A	Ramp inside XWalk1?	N/A	N/A	Ramp inside XWalk2?	N/A
	Road Slope (%)	N/A	N/A	Clear Space?	N/A
	Road X Slope (%)	N/A	N/A	Clear Space to XWalk (in)	N/A
N/A	Any Obstructions?	N/A	N/A	Storm Grate/Utility Hazard?	N/A
	Obstruction Type			Storm Grate/Utility Type	
		N/A			N/A
			Yes	Surface Condition? (G/P)	Good

Remove & Replace Entire Ramp.
