Access Compliance Report

Public Rights-of-Way

(Curb Ramps)

Intersection ID: 10027310	Main Street: GLENEAGLES_RD	Cross Street: N/A	Location: SE
ADA ID: 578D0941EC34	Ramp Type: PerpDiag	Initial Pass/Fail: Fail	Overall Compliance: No
Severity Score: 8.75			
Codes/Mitigation Info/Possible Solution		Field Measurements/Component Compliance

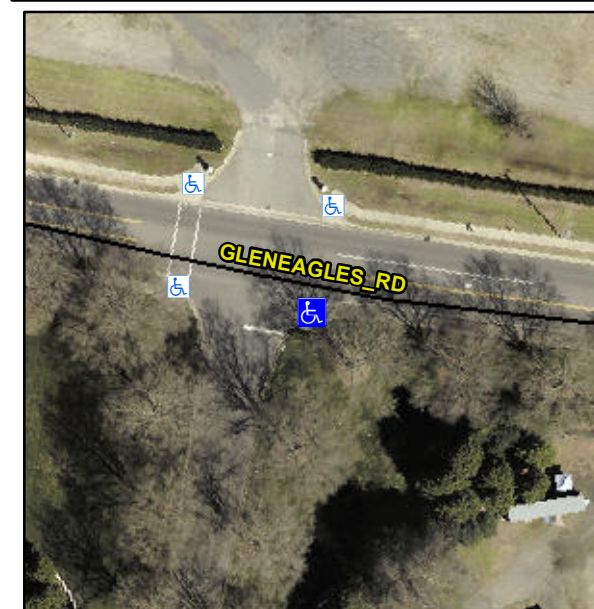
Compliance	Description	Data	Compliance	Description	Data
N/A	Ramp Length (in)	74.0	Yes	Ramp Slope (%)	5.8
No	Ramp Width (in)	38.0	Yes	Ramp XSlope (%)	0.6
N/A	Flare Type LT	N/A	N/A	Flare Type RT	N/A
N/A	Flare Slope LT (%)	N/A	N/A	Flare Slope RT (%)	N/A
N/A	Flare Traversable LT?	N/A	N/A	Flare Traversable RT?	N/A
N/A	Landing Length (in)	N/A	N/A	DWS Provided?	N/A
N/A	Landing Width (in)	N/A	N/A	DWS Contrast?	N/A
N/A	Landing Slope (%)	N/A	N/A	DWS Length (in)	N/A
N/A	Landing X Slope (%)	N/A	N/A	DWS Full Width?	N/A
N/A	Landing Curb? (Y/N)	N/A	N/A	DWS Offset (in)	N/A
N/A	Shared Landing?	N/A			
N/A	Gutter Ponding?	N/A	N/A	Gutter Slope (%)	N/A
N/A	Gutter Lip Ht (in)	N/A	N/A	Gutter X Slope (%)	N/A
N/A	Painted X Walk1?	No	N/A	Painted X Walk2?	No
	X Walk 1 Direction	To N		X Walk 2 Direction	To NW
N/A	X Walk 1 Width (in)	N/A	N/A	X Walk 2 Width (in)	N/A
	X Walk 1 Slope (%)	3.5		X Walk 2 Slope (%)	3.2
	X Walk 1 X Slope (%)	2.7		X Walk 2 X Slope (%)	5.7

N/A	Ramp inside XWalk1?	N/A	N/A	Ramp inside XWalk2?	N/A
	Road Slope (%)	0.5	N/A	Clear Space?	N/A
	Road X Slope (%)	6.9	N/A	Clear Space to XWalk (in)	N/A
N/A	Any Obstructions?	N/A	N/A	Storm Grate/Utility Hazard?	N/A
	Obstruction Type			Storm Grate/Utility Type	
		N/A			N/A
		Yes		Surface Condition? (G/P)	Good

Possible Solutions:

Remove & Replace Curb Ramp With Two New Directional Ramps or Equivalent.

R304.5.1
