Access Compliance Report

Public Rights-of-Way

(Curb Ramps)

Intersection ID: 15177	Main Street: CHARLOTTE_DR	Cross Street: E WORTHINGTON AV	Location: N
ADA ID: 579D0478240E	Ramp Type: PerpDiag	Initial Pass/Fail: Fail	Overall Compliance: No
Codes/Mitigation Info/Possible Solution		Field Measurements/Component Compliance

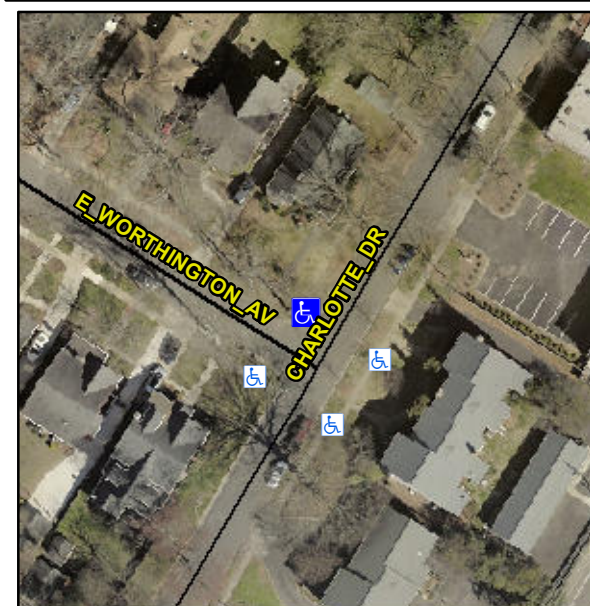
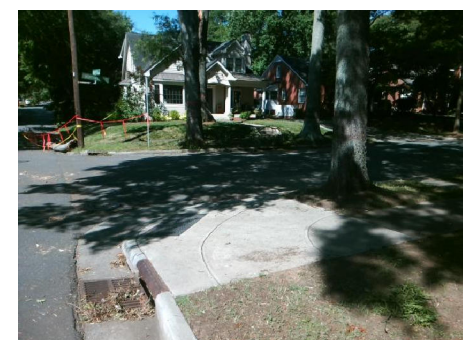
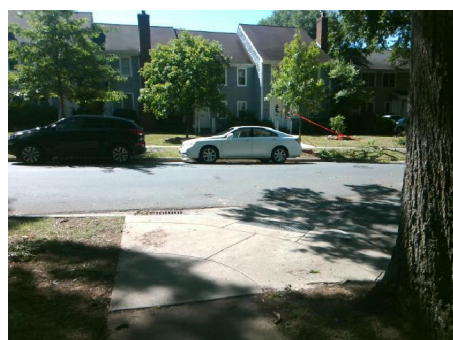
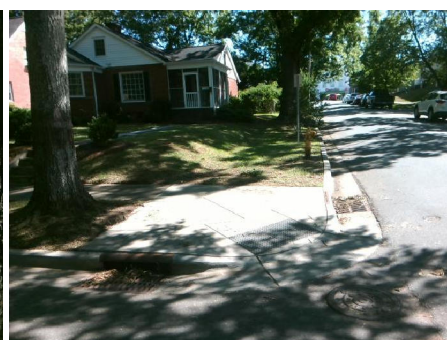
Not Found, R304.2.2, R304.5.3

Compliance	Description	Data	Compliance	Description	Data
N/A	Ramp Length (in)	101.0	No	Ramp Slope (%)	11.2
Yes	Ramp Width (in)	48.0	No	Ramp XSlope (%)	3.9
N/A	Flare Type LT	N/A	N/A	Flare Type RT	N/A
N/A	Flare Slope LT (%)	N/A	N/A	Flare Slope RT (%)	N/A
N/A	Flare Traversable LT?	N/A	N/A	Flare Traversable RT?	N/A
N/A	Landing Length (in)	N/A	N/A	DWS Provided?	N/A
N/A	Landing Width (in)	N/A	N/A	DWS Contrast?	N/A
N/A	Landing Slope (%)	N/A	N/A	DWS Length (in)	N/A
N/A	Landing X Slope (%)	N/A	N/A	DWS Full Width?	N/A
N/A	Landing Curb? (Y/N)	N/A	N/A	DWS Offset (in)	N/A
N/A	Shared Landing?	N/A			
N/A	Gutter Ponding?	N/A	N/A	Gutter Slope (%)	N/A
N/A	Gutter Lip Ht (in)	N/A	N/A	Gutter X Slope (%)	N/A
N/A	Painted X Walk1?	No	N/A	Painted X Walk2?	No
	X Walk 1 Direction	To SW		X Walk 2 Direction	To SE
N/A	X Walk 1 Width (in)	N/A	N/A	X Walk 2 Width (in)	N/A
	X Walk 1 Slope (%)	4.5		X Walk 2 Slope (%)	6.0
	X Walk 1 X Slope (%)	0.1		X Walk 2 X Slope (%)	1.9

N/A	Ramp inside XWalk1?	N/A	N/A	Ramp inside XWalk2?	N/A
	Road Slope (%)	1.0	N/A	Clear Space?	N/A
	Road X Slope (%)	4.0	N/A	Clear Space to XWalk (in)	N/A
N/A	Any Obstructions?	N/A	N/A	Storm Grate/Utility Hazard?	N/A
	Obstruction Type			Storm Grate/Utility Type	
		N/A			N/A
			Yes	Surface Condition? (G/P)	Good

Remove & Replace Curb Ramp With Two New Directional Ramps or Equivalent.
