Access Compliance Report

Public Rights-of-Way

(Curb Ramps)

Intersection ID: 49102	Main Street: PROSPERITY_CROSSING_DR	Cross Street: BENFIELD_RD	Location: E
ADA ID: 579D649FC41C	Ramp Type: Directional1	Initial Pass/Fail: Pass	Overall Compliance: No
Severity Score: 5.25			
Codes/Mitigation Info/Possible Solution		Field Measurements/Component Compliance

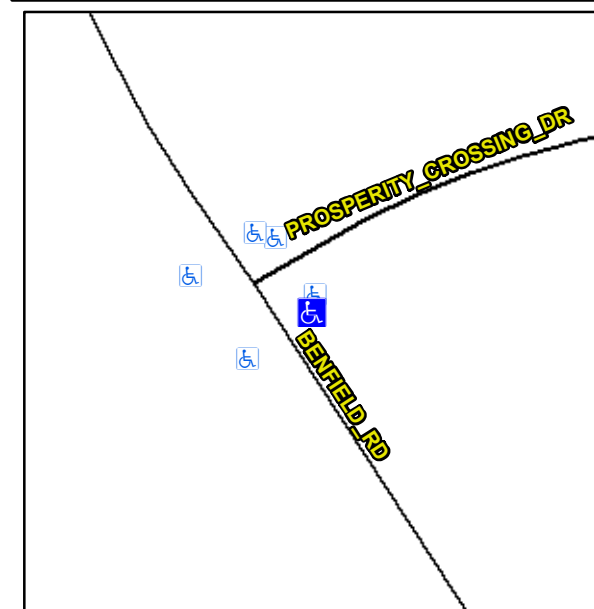
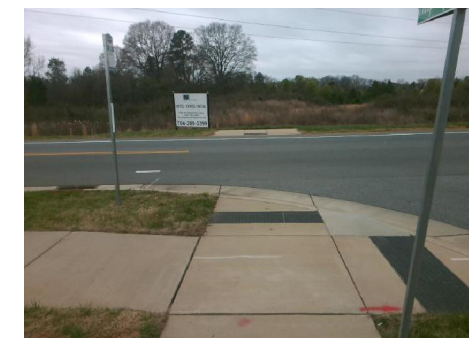
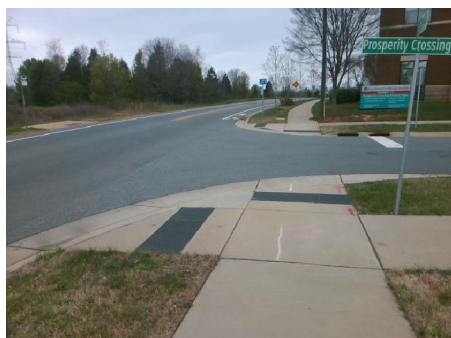
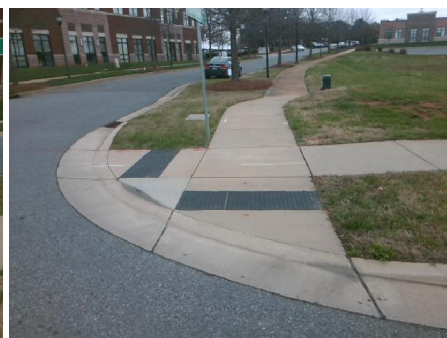
Compliance	Description	Data	Compliance	Description	Data
N/A	Ramp Length (in)	45.0	Yes	Grade Break?	Yes
Yes	Ramp Width (in)	72.0	Yes	Grade Break Slope (%)	3.0
Yes	Ramp Slope (%)	2.7	Yes	Grade Break XSlope (%)	1.5
Yes	Ramp XSlope (%)	2.2			
N/A	Flare Type LT	N/A	N/A	Flare Type RT	N/A
N/A	Flare Slope LT (%)	N/A	N/A	Flare Slope RT (%)	N/A
N/A	Flare Traversable LT?	N/A	N/A	Flare Traversable RT?	N/A
Yes	Landing Length (in)	72.0	Yes	DWS Provided?	Yes
Yes	Landing Width (in)	72.0	Yes	DWS Contrast?	Yes
Yes	Landing Slope (%)	0.8	Yes	DWS Length (in)	24.0
Yes	Landing X Slope (%)	0.8	Yes	DWS Full Width?	Yes
N/A	Landing Curb? (Y/N)	No	Yes	DWS Offset LT (in)	0.0
N/A	Shared Landing?	Yes	Yes	DWS Offset RT (in)	37.0
Yes	Gutter Ponding?	No	No	Gutter Slope (%)	7.3
Yes	Gutter Lip Ht (in)	0.0	Yes	Gutter X Slope (%)	1.3
N/A	Painted X Walk1?	No		Road Slope (%)	2.2
	X Walk 1 Direction	To SW		Road X Slope (%)	3.9
	X Walk 1 Width (in)	N/A		Clear Space?	Yes

X Walk 1 Slope (%)	2.2	N/A	Clear Space to XWalk (in)	N/A
	X Walk 1 X Slope (%)	3.9	Yes	Storm Grate/Utility Hazard?	No
N/A	Ramp inside XWalk1?	N/A		Storm Grate/Utility Type	
Yes	Any Obstructions?	No			N/A
	Obstruction Type		Yes	Surface Condition? (G/P)	Good
			N/A	Curb Slope (%)	5.2

Possible Solutions:

Remove & Replace Gutter.

R304.5.4

Total Cost:

\$ 750.00
