Access Compliance Report Public Rights-of-Way (Curb Ramps)

Intersection ID: 30278Main Street:BLACK_KETTLE_DRCross Street: OLD_IRONSIDE_DRLocation:SWADA ID: 57A2D78D052CRamp Type:BlendTrans1Initial Pass/Fail:FailOverall Compliance: NoSeverity Score:10

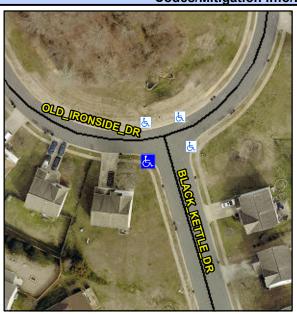
CURB LIP 0.5, LT FL LIP 1.0

Not Found, R304.5.1, R304.5.3

Compliance Description Data Compliance Description Data Yes BlendTrans Slope (%) N/A Ramp Length (in) 46.5 3.4 No No Ramp Width (in) 47.0 BlendTrans XSlope (%) 3.9 N/A N/A Flare Type LT N/A Flare Type RT N/A N/A Flare Slope LT (%) N/A N/A Flare Slope RT (%) N/A N/A Flare Traversable LT? N/A N/A Flare Traversable RT? N/A N/A N/A N/A DWS Provided? N/A Landing Length (in) N/A Landing Width (in) N/A N/A **DWS Contrast?** N/A N/A N/A N/A Landing Slope (%) DWS Length (in) N/A N/A Landing X Slope (%) N/A N/A DWS Full Width? N/A N/A Landing Curb? (Y/N) N/A N/A DWS Offset (in) N/A N/A N/A Shared Landing? N/A **Gutter Ponding?** N/A N/A Gutter Slope (%) N/A N/A Gutter Lip Ht (in) N/A N/A Gutter X Slope (%) N/A N/A Painted X Walk1? No N/A Painted X Walk2? No X Walk 1 Direction To E X Walk 2 Direction To N N/A X Walk 1 Width (in) X Walk 2 Width (in) N/A X Walk 1 Slope (%) 1.3 X Walk 2 Slope (%) 3.8 X Walk 1 X Slope (%) 3.8 X Walk 2 X Slope (%) 0.2 N/A N/A Ramp inside XWalk2? N/A N/A Ramp inside XWalk1? Road Slope (%) 2.4 Clear Space? N/A Road X Slope (%) 0.0 N/A Clear Space to XWalk (in) N/A N/A N/A N/A Any Obstructions? Storm Grate/Utility Hazard? N/A **Obstruction Type** Storm Grate/Utility Type N/A N/A Yes Surface Condition? (G/P) Good No 13.0 Curb Slope (%)

Remove & Replace Curb Ramp With Two New Directional Ramps or Equivalent.
