# Access Compliance Report

## Public Rights-of-Way

### (Curb Ramps)

Intersection ID: 48432	Main Street: WHITHORN_WY	Cross Street: SEAMILL_RD	Location: SE
ADA ID: 57B07F859797	Ramp Type: PerpDiag	Initial Pass/Fail: Fail	Overall Compliance: No
Severity Score: 21.25			
Codes/Mitigation Info/Possible Solution		Field Measurements/Component Compliance

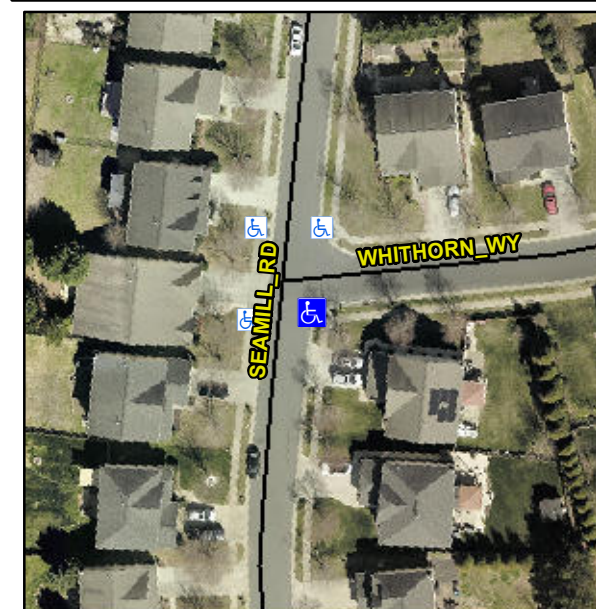
Compliance	Description	Data	Compliance	Description	Data
N/A	Ramp Length (in)	49.0	Yes	Ramp Slope (%)	6.3
No	Ramp Width (in)	44.0	No	Ramp XSlope (%)	5.7
N/A	Flare Type LT	N/A	N/A	Flare Type RT	N/A
N/A	Flare Slope LT (%)	N/A	N/A	Flare Slope RT (%)	N/A
N/A	Flare Traversable LT?	N/A	N/A	Flare Traversable RT?	N/A
N/A	Landing Length (in)	N/A	N/A	DWS Provided?	N/A
N/A	Landing Width (in)	N/A	N/A	DWS Contrast?	N/A
N/A	Landing Slope (%)	N/A	N/A	DWS Length (in)	N/A
N/A	Landing X Slope (%)	N/A	N/A	DWS Full Width?	N/A
N/A	Landing Curb? (Y/N)	N/A	N/A	DWS Offset (in)	N/A
N/A	Shared Landing?	N/A			
N/A	Gutter Ponding?	N/A	N/A	Gutter Slope (%)	N/A
N/A	Gutter Lip Ht (in)	N/A	N/A	Gutter X Slope (%)	N/A
N/A	Painted X Walk1?	No	N/A	Painted X Walk2?	No
	X Walk 1 Direction	To NE		X Walk 2 Direction	To NW
N/A	X Walk 1 Width (in)	N/A	N/A	X Walk 2 Width (in)	N/A
	X Walk 1 Slope (%)	3.8		X Walk 2 Slope (%)	1.5
	X Walk 1 X Slope (%)	0.2		X Walk 2 X Slope (%)	4.4

N/A	Ramp inside XWalk1?	N/A	N/A	Ramp inside XWalk2?	N/A
	Road Slope (%)	3.3	N/A	Clear Space?	N/A
	Road X Slope (%)	4.2	N/A	Clear Space to XWalk (in)	N/A
N/A	Any Obstructions?	N/A	N/A	Storm Grate/Utility Hazard?	N/A
	Obstruction Type			Storm Grate/Utility Type	
		N/A			N/A
		Yes		Surface Condition? (G/P)	Good

**Remove & Replace Curb Ramp With Two New Directional Ramps or Equivalent.**

**R304.5.1, R304.5.3**
