# Access Compliance Report

## Public Rights-of-Way

### (Curb Ramps)

Intersection ID: 8113	Main Street: ORR_RD	Cross Street: GRIER_RD	Location: S
ADA ID: 57B308319653	Ramp Type: Perp	Initial Pass/Fail: Fail	Overall Compliance: No
Severity Score: 21.25			
Codes/Mitigation Info/Possible Solution		Field Measurements/Component Compliance

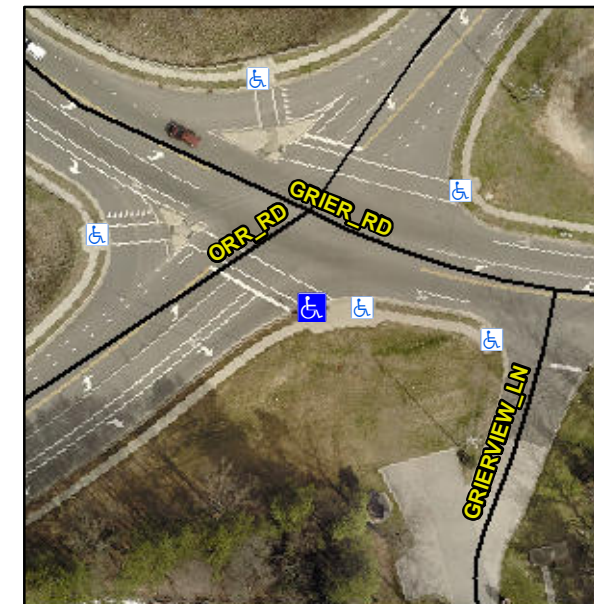
**Not Found, R304.5.1, R304.2.2**

Compliance	Description	Data	Compliance	Description	Data
N/A	Ramp Length (in)	47.0	No	Ramp Slope (%)	9.9
No	Ramp Width (in)	47.5	Yes	Ramp XSlope (%)	1.0
N/A	Flare Type LT	N/A	N/A	Flare Type RT	N/A
N/A	Flare Slope LT (%)	N/A	N/A	Flare Slope RT (%)	N/A
N/A	Flare Traversable LT?	N/A	N/A	Flare Traversable RT?	N/A
N/A	Landing Length (in)	N/A	N/A	DWS Provided?	N/A
N/A	Landing Width (in)	N/A	N/A	DWS Contrast?	N/A
N/A	Landing Slope (%)	N/A	N/A	DWS Length (in)	N/A
N/A	Landing X Slope (%)	N/A	N/A	DWS Full Width?	N/A
N/A	Landing Curb? (Y/N)	N/A	N/A	DWS Offset (in)	N/A
N/A	Shared Landing?	N/A			
N/A	Gutter Ponding?	N/A	N/A	Gutter Slope (%)	N/A
N/A	Gutter Lip Ht (in)	N/A	N/A	Gutter X Slope (%)	N/A
N/A	Painted X Walk1?	Yes	N/A	Painted X Walk2?	N/A
	X Walk 1 Direction	To NW		X Walk 2 Direction	N/A
N/A	X Walk 1 Width (in)	117.0	N/A	X Walk 2 Width (in)	N/A
	X Walk 1 Slope (%)	0.0		X Walk 2 Slope (%)	N/A
	X Walk 1 X Slope (%)	1.6		X Walk 2 X Slope (%)	N/A

N/A	Ramp inside XWalk1?	Yes	N/A	Ramp inside XWalk2?	N/A
	Road Slope (%)	N/A	N/A	Clear Space?	N/A
	Road X Slope (%)	N/A	N/A	Clear Space to XWalk (in)	N/A
N/A	Any Obstructions?	N/A	N/A	Storm Grate/Utility Hazard?	N/A
	Obstruction Type			Storm Grate/Utility Type	
		N/A			N/A
			Yes	Surface Condition? (G/P)	Good

**Remove & Replace Entire Ramp.**

Total Cost: \$ 1850.00
