Access Compliance Report

Public Rights-of-Way

(Curb Ramps)

Intersection ID: 7225	Main Street: STATESVILLE_RD	Cross Street: STARITA_RD	Location: NE
ADA ID: 57BE5A648AF7	Ramp Type: Perp	Initial Pass/Fail: Fail	Overall Compliance: No
		Severity Score: 8.75

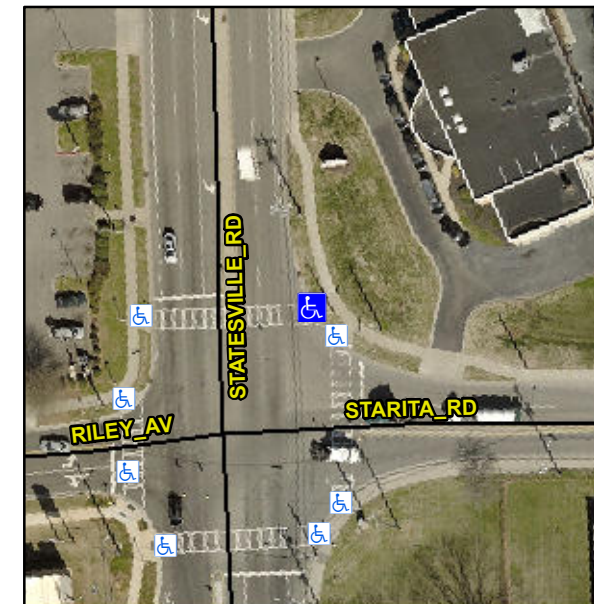
Not Found, R304.5.1

Compliance	Description	Data	Compliance	Description	Data
N/A	Ramp Length (in)	120.0	Yes	Ramp Slope (%)	7.4
No	Ramp Width (in)	47.5	Yes	Ramp XSlope (%)	1.4
N/A	Flare Type LT	N/A	N/A	Flare Type RT	N/A
N/A	Flare Slope LT (%)	N/A	N/A	Flare Slope RT (%)	N/A
N/A	Flare Traversable LT?	N/A	N/A	Flare Traversable RT?	N/A
N/A	Landing Length (in)	N/A	N/A	DWS Provided?	N/A
N/A	Landing Width (in)	N/A	N/A	DWS Contrast?	N/A
N/A	Landing Slope (%)	N/A	N/A	DWS Length (in)	N/A
N/A	Landing X Slope (%)	N/A	N/A	DWS Full Width?	N/A
N/A	Landing Curb? (Y/N)	N/A	N/A	DWS Offset (in)	N/A
N/A	Shared Landing?	N/A			
N/A	Gutter Ponding?	N/A	N/A	Gutter Slope (%)	N/A
N/A	Gutter Lip Ht (in)	N/A	N/A	Gutter X Slope (%)	N/A
N/A	Painted X Walk1?	Yes	N/A	Painted X Walk2?	N/A
	X Walk 1 Direction	To W		X Walk 2 Direction	N/A
N/A	X Walk 1 Width (in)	110.5	N/A	X Walk 2 Width (in)	N/A
	X Walk 1 Slope (%)	1.1		X Walk 2 Slope (%)	N/A
	X Walk 1 X Slope (%)	2.3		X Walk 2 X Slope (%)	N/A

N/A	Ramp inside XWalk1?	Yes	N/A	Ramp inside XWalk2?	N/A
	Road Slope (%)	N/A	N/A	Clear Space?	N/A
	Road X Slope (%)	N/A	N/A	Clear Space to XWalk (in)	N/A
N/A	Any Obstructions?	N/A	N/A	Storm Grate/Utility Hazard?	N/A
	Obstruction Type			Storm Grate/Utility Type	
		N/A			N/A
			Yes	Surface Condition? (G/P)	Good

Remove & Replace Entire Ramp.
