Access Compliance Report

Public Rights-of-Way

(Curb Ramps)

Intersection ID: 26566	Main Street: ARBORHILL_RD	Cross Street: STIRRUP_RIDGE_LN	Location: SW
ADA ID: 57C8270C06DD	Ramp Type: Perp	Initial Pass/Fail: Fail	Overall Compliance: No
			Severity Score: 10

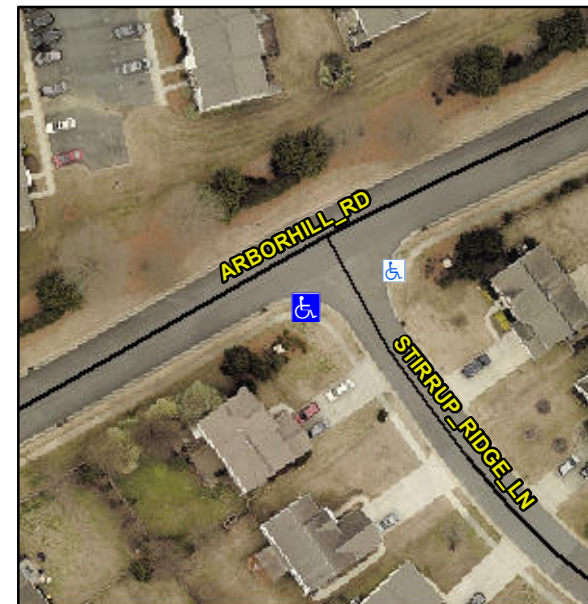
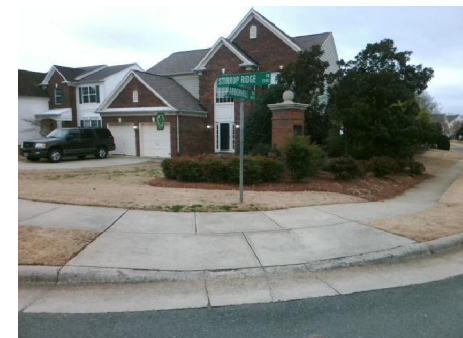
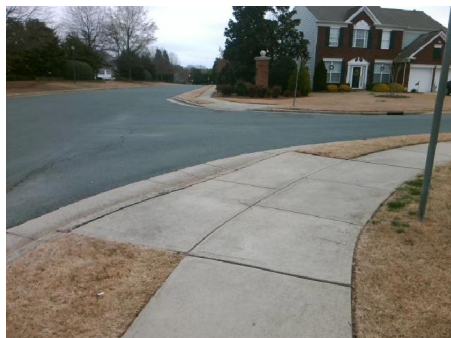
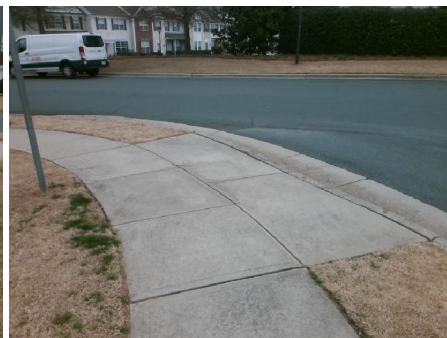
Not Found, R304.5.1, R304.5.3

Compliance	Description	Data	Compliance	Description	Data
N/A	Ramp Length (in)	48.0	Yes	Ramp Slope (%)	5.8
No	Ramp Width (in)	47.0	No	Ramp XSlope (%)	3.4
N/A	Flare Type LT	N/A	N/A	Flare Type RT	N/A
N/A	Flare Slope LT (%)	N/A	N/A	Flare Slope RT (%)	N/A
N/A	Flare Traversable LT?	N/A	N/A	Flare Traversable RT?	N/A
N/A	Landing Length (in)	N/A	N/A	DWS Provided?	N/A
N/A	Landing Width (in)	N/A	N/A	DWS Contrast?	N/A
N/A	Landing Slope (%)	N/A	N/A	DWS Length (in)	N/A
N/A	Landing X Slope (%)	N/A	N/A	DWS Full Width?	N/A
N/A	Landing Curb? (Y/N)	N/A	N/A	DWS Offset (in)	N/A
N/A	Shared Landing?	N/A			
N/A	Gutter Ponding?	N/A	N/A	Gutter Slope (%)	N/A
N/A	Gutter Lip Ht (in)	N/A	N/A	Gutter X Slope (%)	N/A
N/A	Painted X Walk1?	No	N/A	Painted X Walk2?	N/A
	X Walk 1 Direction	To W		X Walk 2 Direction	N/A
N/A	X Walk 1 Width (in)	N/A	N/A	X Walk 2 Width (in)	N/A
	X Walk 1 Slope (%)	0.7		X Walk 2 Slope (%)	N/A
	X Walk 1 X Slope (%)	3.0		X Walk 2 X Slope (%)	N/A

N/A	Ramp inside XWalk1?	N/A	N/A	Ramp inside XWalk2?	N/A
	Road Slope (%)	N/A	N/A	Clear Space?	N/A
	Road X Slope (%)	N/A	N/A	Clear Space to XWalk (in)	N/A
N/A	Any Obstructions?	N/A	N/A	Storm Grate/Utility Hazard?	N/A
	Obstruction Type			Storm Grate/Utility Type	
		N/A			N/A
			Yes	Surface Condition? (G/P)	Good

Remove & Replace Entire Ramp.
