# Access Compliance Report

## Public Rights-of-Way

### (Curb Ramps)

Intersection ID: 4986	Main Street: CELOSIA_DR	Cross Street: MORNING_GLORY_DR	Location: NE
ADA ID: 57C8E63E3BB4	Ramp Type: Perp	Initial Pass/Fail: Fail	Overall Compliance: No
Severity Score: 22.5			
Codes/Mitigation Info/Possible Solution		Field Measurements/Component Compliance

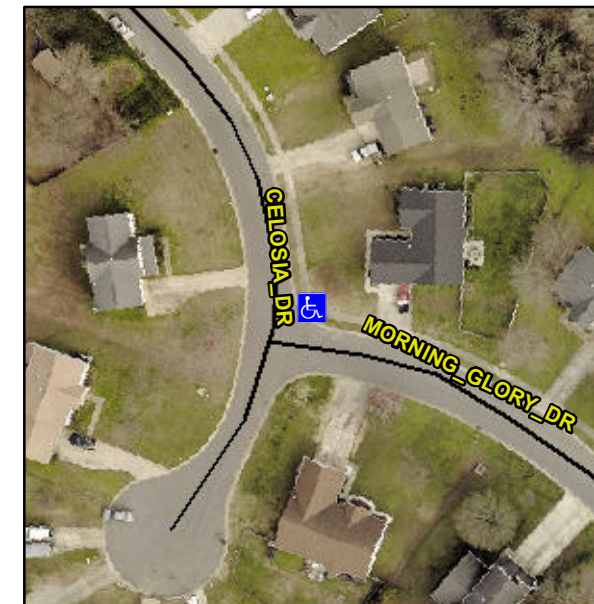
Compliance	Description	Data	Compliance	Description	Data
N/A	Ramp Length (in)	51.0	No	Ramp Slope (%)	9.5
No	Ramp Width (in)	46.0	No	Ramp XSlope (%)	2.1
N/A	Flare Type LT	N/A	N/A	Flare Type RT	N/A
N/A	Flare Slope LT (%)	N/A	N/A	Flare Slope RT (%)	N/A
N/A	Flare Traversable LT?	N/A	N/A	Flare Traversable RT?	N/A
N/A	Landing Length (in)	N/A	N/A	DWS Provided?	N/A
N/A	Landing Width (in)	N/A	N/A	DWS Contrast?	N/A
N/A	Landing Slope (%)	N/A	N/A	DWS Length (in)	N/A
N/A	Landing X Slope (%)	N/A	N/A	DWS Full Width?	N/A
N/A	Landing Curb? (Y/N)	N/A	N/A	DWS Offset (in)	N/A
N/A	Shared Landing?	N/A			
N/A	Gutter Ponding?	N/A	N/A	Gutter Slope (%)	N/A
N/A	Gutter Lip Ht (in)	N/A	N/A	Gutter X Slope (%)	N/A
N/A	Painted X Walk1?	No	N/A	Painted X Walk2?	N/A
	X Walk 1 Direction	To S		X Walk 2 Direction	N/A
N/A	X Walk 1 Width (in)	N/A	N/A	X Walk 2 Width (in)	N/A
	X Walk 1 Slope (%)	6.0		X Walk 2 Slope (%)	N/A
	X Walk 1 X Slope (%)	2.3		X Walk 2 X Slope (%)	N/A

N/A	Ramp inside XWalk1?	N/A	N/A	Ramp inside XWalk2?	N/A
	Road Slope (%)	N/A	N/A	Clear Space?	N/A
	Road X Slope (%)	N/A	N/A	Clear Space to XWalk (in)	N/A
N/A	Any Obstructions?	N/A	N/A	Storm Grate/Utility Hazard?	N/A
	Obstruction Type			Storm Grate/Utility Type	
		N/A			N/A
			Yes	Surface Condition? (G/P)	Good

Possible Solutions:

**Remove & Replace Entire Ramp.**

**R304.5.1, R304.2.2, R304.5.3**

Total Cost: \$ 1850.00
