Access Compliance Report

Public Rights-of-Way

(Curb Ramps)

Intersection ID: 20390	Main Street: OLD_PINEVILLE_RD	Cross Street: GREENHILL_DR	Location: SW
ADA ID: 57CA06FAE8EC	Ramp Type: Directional1	Initial Pass/Fail: Fail	Overall Compliance: No
		Severity Score: 12.5

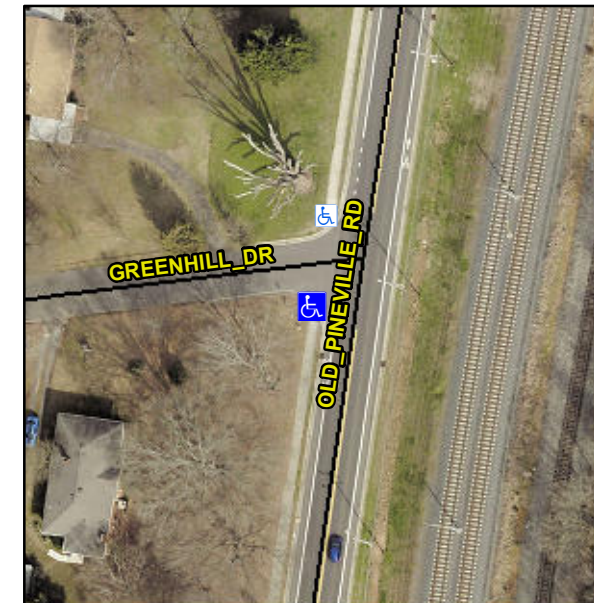
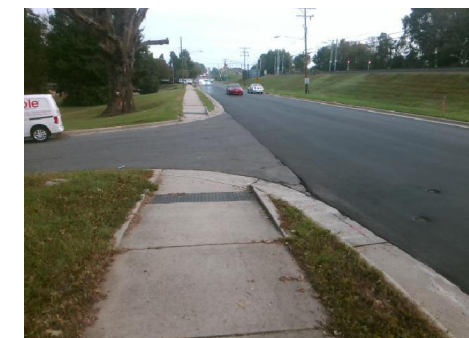
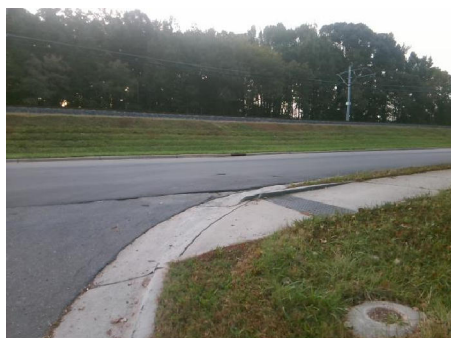
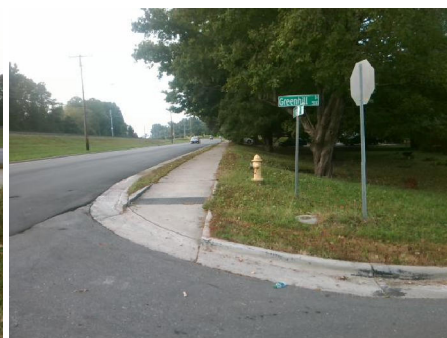
Compliance	Description	Data	Compliance	Description	Data
N/A	Ramp Length (in)	72.0	N/A	Grade Break?	N/A
Yes	Ramp Width (in)	72.0	N/A	Grade Break Slope (%)	0.0
No	Ramp Slope (%)	10.2	N/A	Grade Break XSlope (%)	0.0
Yes	Ramp XSlope (%)	2.0			
N/A	Flare Type LT	N/A	N/A	Flare Type RT	N/A
N/A	Flare Slope LT (%)	N/A	N/A	Flare Slope RT (%)	0.0
N/A	Flare Traversable LT?	N/A	N/A	Flare Traversable RT?	N/A
N/A	Landing Length (in)	0.0	N/A	DWS Provided?	N/A
N/A	Landing Width (in)	0.0	N/A	DWS Contrast?	N/A
N/A	Landing Slope (%)	0.0	N/A	DWS Length (in)	N/A
N/A	Landing X Slope (%)	0.0	N/A	DWS Full Width?	N/A
N/A	Landing Curb? (Y/N)	N/A	N/A	DWS Offset LT (in)	N/A
N/A	Shared Landing?	N/A	N/A	DWS Offset RT (in)	N/A
N/A	Gutter Ponding?	0.0	N/A	Gutter Slope (%)	N/A
N/A	Gutter Lip Ht (in)	0.0	N/A	Gutter X Slope (%)	N/A
N/A	Painted X Walk1?	No		Road Slope (%)	0.5
	X Walk 1 Direction	To N		Road X Slope (%)	10.3
	X Walk 1 Width (in)	N/A		Clear Space?	N/A

X Walk 1 Slope (%)	0.5	N/A	Clear Space to XWalk (in)	N/A
	X Walk 1 X Slope (%)	10.3	N/A	Storm Grate/Utility Hazard?	N/A
N/A	Ramp inside XWalk1?	N/A		Storm Grate/Utility Type	
N/A	Any Obstructions?	N/A			N/A
	Obstruction Type		Yes	Surface Condition? (G/P)	Good
			N/A	Curb Slope (%)	15.4

Possible Solutions:

Remove & Replace Entire Ramp.
