# Access Compliance Report

## Public Rights-of-Way

### (Curb Ramps)

Intersection ID: 3825	Main Street: GARRISON_RD	Cross Street: LADORA_DR	Location: W
ADA ID: 57E980CEDEA8	Ramp Type: PerpDiag	Initial Pass/Fail: Fail	Overall Compliance: No
Severity Score: 46.25			
Codes/Mitigation Info/Possible Solution		Field Measurements/Component Compliance

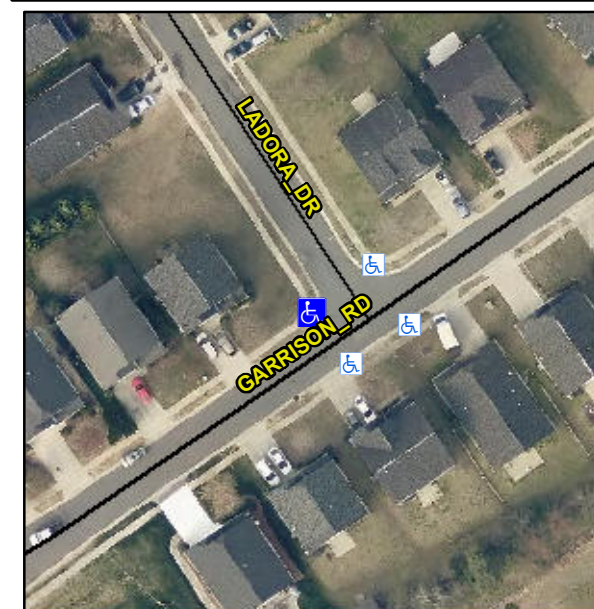
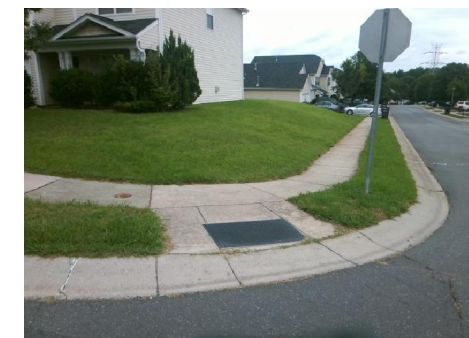
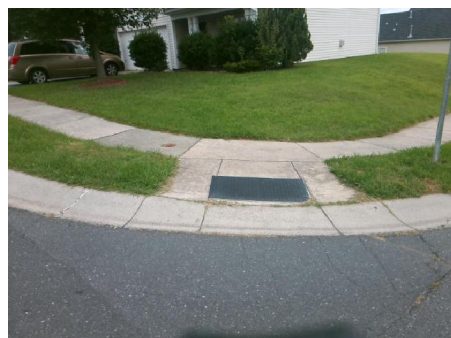
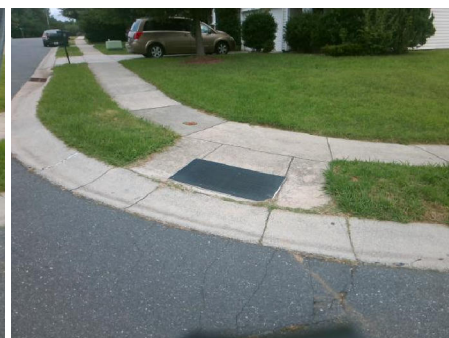
**Not Found, R304.5.1, R304.2.2, R304.5.3**

Compliance	Description	Data	Compliance	Description	Data
N/A	Ramp Length (in)	51.0	No	Ramp Slope (%)	9.0
No	Ramp Width (in)	39.0	No	Ramp XSlope (%)	10.1
N/A	Flare Type LT	N/A	N/A	Flare Type RT	N/A
N/A	Flare Slope LT (%)	N/A	N/A	Flare Slope RT (%)	N/A
N/A	Flare Traversable LT?	N/A	N/A	Flare Traversable RT?	N/A
N/A	Landing Length (in)	N/A	N/A	DWS Provided?	N/A
N/A	Landing Width (in)	N/A	N/A	DWS Contrast?	N/A
N/A	Landing Slope (%)	N/A	N/A	DWS Length (in)	N/A
N/A	Landing X Slope (%)	N/A	N/A	DWS Full Width?	N/A
N/A	Landing Curb? (Y/N)	N/A	N/A	DWS Offset (in)	N/A
N/A	Shared Landing?	N/A			
N/A	Gutter Ponding?	N/A	N/A	Gutter Slope (%)	N/A
N/A	Gutter Lip Ht (in)	N/A	N/A	Gutter X Slope (%)	N/A
N/A	Painted X Walk1?	No	N/A	Painted X Walk2?	No
	X Walk 1 Direction	To SE		X Walk 2 Direction	To NE
N/A	X Walk 1 Width (in)	N/A	N/A	X Walk 2 Width (in)	N/A
	X Walk 1 Slope (%)	8.5		X Walk 2 Slope (%)	0.1
	X Walk 1 X Slope (%)	3.0		X Walk 2 X Slope (%)	7.0

N/A	Ramp inside XWalk1?	N/A	N/A	Ramp inside XWalk2?	N/A
	Road Slope (%)	6.8	N/A	Clear Space?	N/A
	Road X Slope (%)	1.6	N/A	Clear Space to XWalk (in)	N/A
N/A	Any Obstructions?	N/A	N/A	Storm Grate/Utility Hazard?	N/A
	Obstruction Type			Storm Grate/Utility Type	
		N/A			N/A
			Yes	Surface Condition? (G/P)	Good

**Remove & Replace Curb Ramp With Two New Directional Ramps or Equivalent.**
