# Access Compliance Report

## Public Rights-of-Way

### (Curb Ramps)

Intersection ID: 29484	Main Street: SETTLEMYER_CT	Cross Street: WILORA_LANDING_RD	Location: SE
ADA ID: 5812E54FE79C	Ramp Type: BlendTrans1	Initial Pass/Fail: Fail	Overall Compliance: No
Severity Score: 42.5			
Codes/Mitigation Info/Possible Solution		Field Measurements/Component Compliance

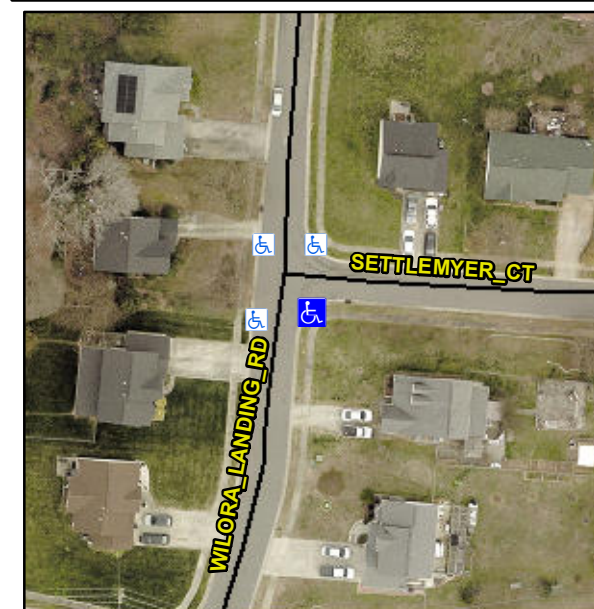
**Not Found, R304.5.1, R304.5.3**

Compliance	Description	Data	Compliance	Description	Data
N/A	Ramp Length (in)	96.0	Yes	BlendTrans Slope (%)	4.5
No	Ramp Width (in)	34.0	No	BlendTrans XSlope (%)	10.8
N/A	Flare Type LT	N/A	N/A	Flare Type RT	N/A
N/A	Flare Slope LT (%)	N/A	N/A	Flare Slope RT (%)	N/A
N/A	Flare Traversable LT?	N/A	N/A	Flare Traversable RT?	N/A
N/A	Landing Length (in)	N/A	N/A	DWS Provided?	N/A
N/A	Landing Width (in)	N/A	N/A	DWS Contrast?	N/A
N/A	Landing Slope (%)	N/A	N/A	DWS Length (in)	N/A
N/A	Landing X Slope (%)	N/A	N/A	DWS Full Width?	N/A
N/A	Landing Curb? (Y/N)	N/A	N/A	DWS Offset (in)	N/A
N/A	Shared Landing?	N/A			
N/A	Gutter Ponding?	N/A	N/A	Gutter Slope (%)	N/A
N/A	Gutter Lip Ht (in)	N/A	N/A	Gutter X Slope (%)	N/A
N/A	Painted X Walk1?	No	N/A	Painted X Walk2?	No
	X Walk 1 Direction	To N		X Walk 2 Direction	To W
	X Walk 1 Width (in)	N/A		X Walk 2 Width (in)	N/A
	X Walk 1 Slope (%)	3.2		X Walk 2 Slope (%)	3.0
	X Walk 1 X Slope (%)	6.3		X Walk 2 X Slope (%)	5.4

N/A	Ramp inside XWalk1?	N/A	N/A	Ramp inside XWalk2?	N/A
	Road Slope (%)	8.1		Clear Space?	N/A
	Road X Slope (%)	0.8	N/A	Clear Space to XWalk (in)	N/A
N/A	Any Obstructions?	N/A	N/A	Storm Grate/Utility Hazard?	N/A
	Obstruction Type			Storm Grate/Utility Type	
		N/A			N/A
			Yes	Surface Condition? (G/P)	Good
			No	Curb Slope (%)	11.1

**Remove & Replace Curb Ramp With Two New Directional Ramps or Equivalent.**
