# Access Compliance Report

## Public Rights-of-Way

### (Curb Ramps)

Intersection ID: 25495	Main Street: CARMEL_RD	Cross Street: WATERFORD_SQUARE_DR	Location: NW
ADA ID: 5822EAC8121F	Ramp Type: PerpDiag	Initial Pass/Fail: Fail	Overall Compliance: No
Severity Score: 21.25			
Codes/Mitigation Info/Possible Solution		Field Measurements/Component Compliance

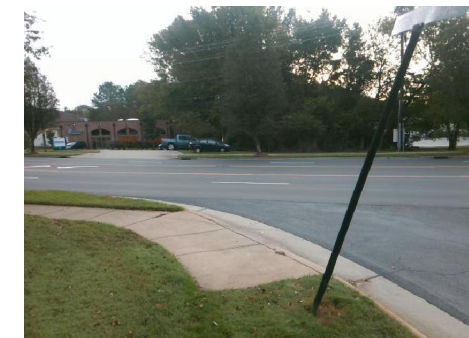
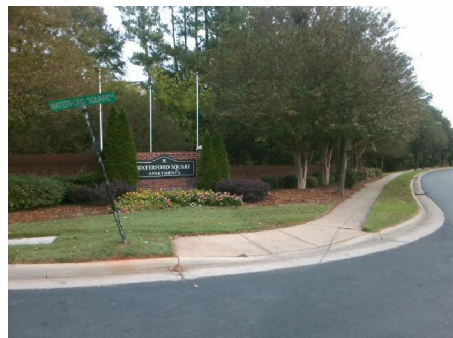
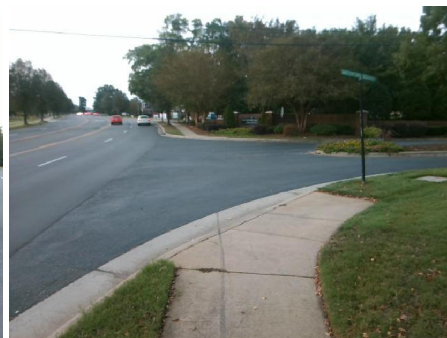
Compliance	Description	Data	Compliance	Description	Data
N/A	Ramp Length (in)	60.0	No	Ramp Slope (%)	8.5
No	Ramp Width (in)	41.0	Yes	Ramp XSlope (%)	1.9
N/A	Flare Type LT	N/A	N/A	Flare Type RT	N/A
N/A	Flare Slope LT (%)	N/A	N/A	Flare Slope RT (%)	N/A
N/A	Flare Traversable LT?	N/A	N/A	Flare Traversable RT?	N/A
N/A	Landing Length (in)	N/A	N/A	DWS Provided?	N/A
N/A	Landing Width (in)	N/A	N/A	DWS Contrast?	N/A
N/A	Landing Slope (%)	N/A	N/A	DWS Length (in)	N/A
N/A	Landing X Slope (%)	N/A	N/A	DWS Full Width?	N/A
N/A	Landing Curb? (Y/N)	N/A	N/A	DWS Offset (in)	N/A
N/A	Shared Landing?	N/A			
N/A	Gutter Ponding?	N/A	N/A	Gutter Slope (%)	N/A
N/A	Gutter Lip Ht (in)	N/A	N/A	Gutter X Slope (%)	N/A
N/A	Painted X Walk1?	No	N/A	Painted X Walk2?	No
	X Walk 1 Direction	To SW		X Walk 2 Direction	To SE
N/A	X Walk 1 Width (in)	N/A	N/A	X Walk 2 Width (in)	N/A
	X Walk 1 Slope (%)	1.5		X Walk 2 Slope (%)	0.3
	X Walk 1 X Slope (%)	2.8		X Walk 2 X Slope (%)	1.0

N/A	Ramp inside XWalk1?	N/A	N/A	Ramp inside XWalk2?	N/A
	Road Slope (%)	1.1	N/A	Clear Space?	N/A
	Road X Slope (%)	3.2	N/A	Clear Space to XWalk (in)	N/A
N/A	Any Obstructions?	N/A	N/A	Storm Grate/Utility Hazard?	N/A
	Obstruction Type			Storm Grate/Utility Type	
		N/A			N/A
			Yes	Surface Condition? (G/P)	Good

**Remove & Replace Curb Ramp With Two New Directional Ramps or Equivalent.**
