# Access Compliance Report

## Public Rights-of-Way

| Intersection ID: 13871 | Main Street: E_5TH_ST | Cross Street: HAWTHORNE_LN | Location: NW |
| ADA ID: 582A0D681F53 | Ramp Type: Directional1 | Initial Pass/Fail: Fail | Overall Compliance: No |

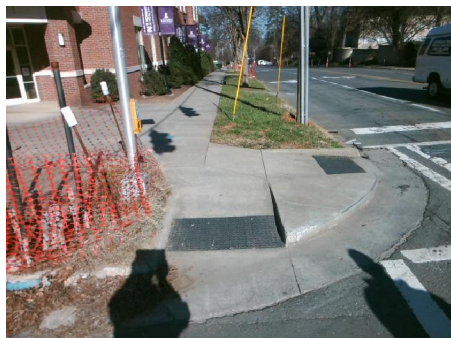
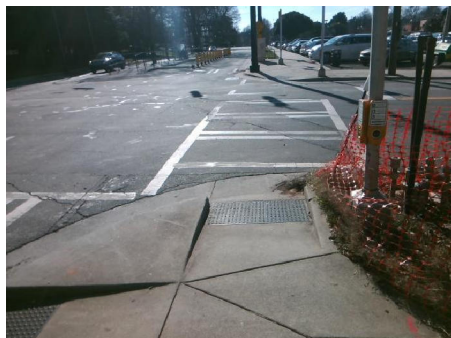
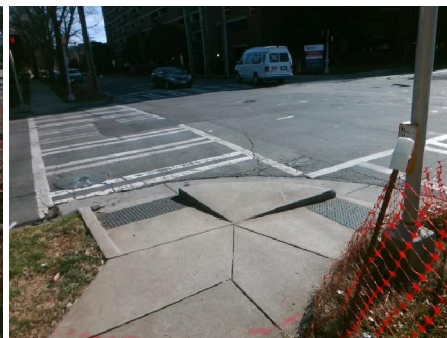
| | | Severity Score: 35 | |

**R304.5.1, R304.2.2, R304.5.3**

| Compliance | Description | Data | Compliance | Description | Data |
|---|---|---|---|---|---|
| No | Ramp Width (in) | <b>46.5</b> | N/A | Grade Break Slope (%) | <b>0.0</b> |
| No | Ramp Slope (%) | <b>12.1</b> | N/A | Grade Break XSlope (%) | <b>0.0</b> |
| No | Ramp XSlope (%) | <b>3.9</b> | | | |

**Remove & Replace Entire Ramp.**

Total Cost: \$ **1600.00**
