Access Compliance Report

Public Rights-of-Way

(Curb Ramps)

Intersection ID: 50635	Main Street: RED_WATER_RD	Cross Street: BLUE_BLOSSOM_RD	Location: NE
ADA ID: 582D55203007	Ramp Type: Perp	Initial Pass/Fail: Fail	Overall Compliance: No
Severity Score: 8.75			
Codes/Mitigation Info/Possible Solution		Field Measurements/Component Compliance

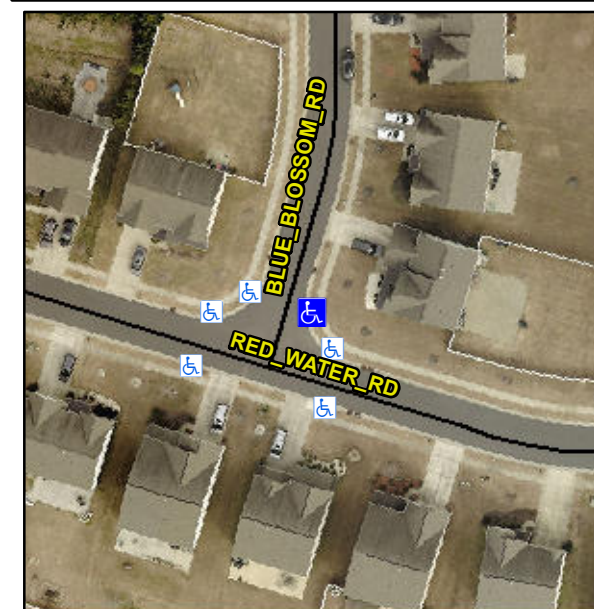
Compliance	Description	Data	Compliance	Description	Data
N/A	Ramp Length (in)	46.5	Yes	Ramp Slope (%)	6.7
No	Ramp Width (in)	46.0	Yes	Ramp XSlope (%)	1.7
N/A	Flare Type LT	N/A	N/A	Flare Type RT	N/A
N/A	Flare Slope LT (%)	N/A	N/A	Flare Slope RT (%)	N/A
N/A	Flare Traversable LT?	N/A	N/A	Flare Traversable RT?	N/A
N/A	Landing Length (in)	N/A	N/A	DWS Provided?	N/A
N/A	Landing Width (in)	N/A	N/A	DWS Contrast?	N/A
N/A	Landing Slope (%)	N/A	N/A	DWS Length (in)	N/A
N/A	Landing X Slope (%)	N/A	N/A	DWS Full Width?	N/A
N/A	Landing Curb? (Y/N)	N/A	N/A	DWS Offset (in)	N/A
N/A	Shared Landing?	N/A			
N/A	Gutter Ponding?	N/A	N/A	Gutter Slope (%)	N/A
N/A	Gutter Lip Ht (in)	N/A	N/A	Gutter X Slope (%)	N/A
N/A	Painted X Walk1?	No	N/A	Painted X Walk2?	N/A
	X Walk 1 Direction	To NW		X Walk 2 Direction	N/A
N/A	X Walk 1 Width (in)	N/A	N/A	X Walk 2 Width (in)	N/A
	X Walk 1 Slope (%)	0.6		X Walk 2 Slope (%)	N/A
	X Walk 1 X Slope (%)	2.5		X Walk 2 X Slope (%)	N/A

N/A	Ramp inside XWalk1?	N/A	N/A	Ramp inside XWalk2?	N/A
	Road Slope (%)	N/A	N/A	Clear Space?	N/A
	Road X Slope (%)	N/A	N/A	Clear Space to XWalk (in)	N/A
N/A	Any Obstructions?	N/A	N/A	Storm Grate/Utility Hazard?	N/A
	Obstruction Type			Storm Grate/Utility Type	
		N/A			N/A
		Yes		Surface Condition? (G/P)	Good

Possible Solutions:

Remove & Replace Entire Ramp.

Not Found, R304.5.1
