# Access Compliance Report

## Public Rights-of-Way

### (Curb Ramps)

Intersection ID: 26688	Main Street: STIRRUP_RIDGE_LN	Cross Street: WINTHROP_RIDGE_RD	Location: NW
ADA ID: 5836E5F52CAD	Ramp Type: Perp	Initial Pass/Fail: Fail	Overall Compliance: No
		Severity Score: 10

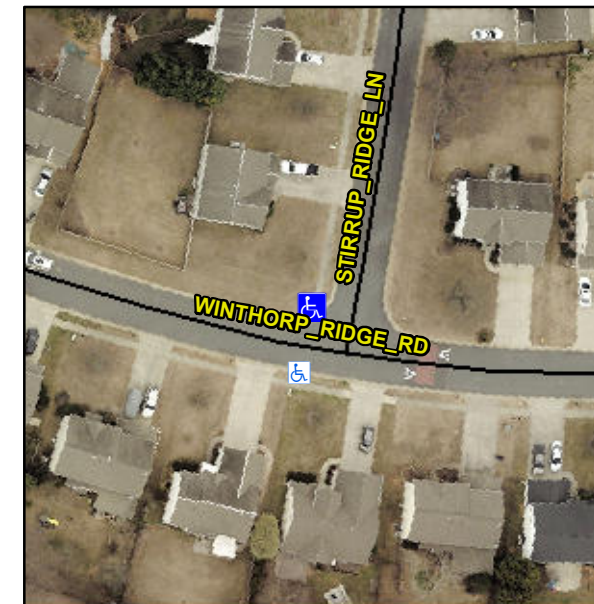
**Not Found, R304.5.1, R304.5.3**

Compliance	Description	Data	Compliance	Description	Data
N/A	Ramp Length (in)	47.5	Yes	Ramp Slope (%)	8.1
No	Ramp Width (in)	41.0	No	Ramp XSlope (%)	3.5
N/A	Flare Type LT	N/A	N/A	Flare Type RT	N/A
N/A	Flare Slope LT (%)	N/A	N/A	Flare Slope RT (%)	N/A
N/A	Flare Traversable LT?	N/A	N/A	Flare Traversable RT?	N/A
N/A	Landing Length (in)	N/A	N/A	DWS Provided?	N/A
N/A	Landing Width (in)	N/A	N/A	DWS Contrast?	N/A
N/A	Landing Slope (%)	N/A	N/A	DWS Length (in)	N/A
N/A	Landing X Slope (%)	N/A	N/A	DWS Full Width?	N/A
N/A	Landing Curb? (Y/N)	N/A	N/A	DWS Offset (in)	N/A
N/A	Shared Landing?	N/A			
N/A	Gutter Ponding?	N/A	N/A	Gutter Slope (%)	N/A
N/A	Gutter Lip Ht (in)	N/A	N/A	Gutter X Slope (%)	N/A
N/A	Painted X Walk1?	No	N/A	Painted X Walk2?	N/A
	X Walk 1 Direction	To S		X Walk 2 Direction	N/A
N/A	X Walk 1 Width (in)	N/A	N/A	X Walk 2 Width (in)	N/A
	X Walk 1 Slope (%)	2.8		X Walk 2 Slope (%)	N/A
	X Walk 1 X Slope (%)	0.1		X Walk 2 X Slope (%)	N/A

N/A	Ramp inside XWalk1?	N/A	N/A	Ramp inside XWalk2?	N/A
	Road Slope (%)	N/A	N/A	Clear Space?	N/A
	Road X Slope (%)	N/A	N/A	Clear Space to XWalk (in)	N/A
N/A	Any Obstructions?	N/A	N/A	Storm Grate/Utility Hazard?	N/A
	Obstruction Type			Storm Grate/Utility Type	
		N/A			N/A
			Yes	Surface Condition? (G/P)	Good

**Remove & Replace Entire Ramp.**
