# Access Compliance Report

## Public Rights-of-Way

### (Curb Ramps)

Intersection ID: 11685	Main Street: E_19TH_ST	Cross Street: SEIGLE_AV	Location: W
ADA ID: 583800DCE004	Ramp Type: Perp	Initial Pass/Fail: Fail	Overall Compliance: No
Severity Score: 33.75			
Codes/Mitigation Info/Possible Solution		Field Measurements/Component Compliance

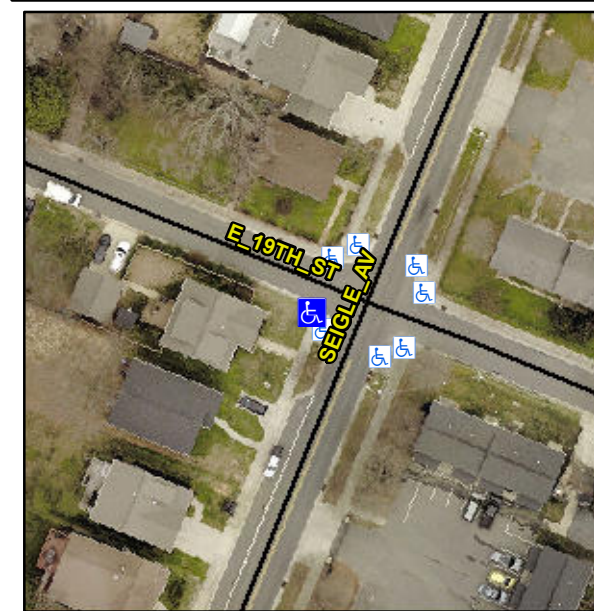
**Not Found, R304.5.1, R304.2.2, R304.5.3**

Compliance	Description	Data	Compliance	Description	Data
N/A	Ramp Length (in)	70.0	No	Ramp Slope (%)	11.5
No	Ramp Width (in)	47.5	No	Ramp XSlope (%)	6.5
N/A	Flare Type LT	N/A	N/A	Flare Type RT	N/A
N/A	Flare Slope LT (%)	N/A	N/A	Flare Slope RT (%)	N/A
N/A	Flare Traversable LT?	N/A	N/A	Flare Traversable RT?	N/A
N/A	Landing Length (in)	N/A	N/A	DWS Provided?	N/A
N/A	Landing Width (in)	N/A	N/A	DWS Contrast?	N/A
N/A	Landing Slope (%)	N/A	N/A	DWS Length (in)	N/A
N/A	Landing X Slope (%)	N/A	N/A	DWS Full Width?	N/A
N/A	Landing Curb? (Y/N)	N/A	N/A	DWS Offset (in)	N/A
N/A	Shared Landing?	N/A			
N/A	Gutter Ponding?	N/A	N/A	Gutter Slope (%)	N/A
N/A	Gutter Lip Ht (in)	N/A	N/A	Gutter X Slope (%)	N/A
N/A	Painted X Walk1?	No	N/A	Painted X Walk2?	N/A
	X Walk 1 Direction	To NE		X Walk 2 Direction	N/A
N/A	X Walk 1 Width (in)	N/A	N/A	X Walk 2 Width (in)	N/A
	X Walk 1 Slope (%)	3.1		X Walk 2 Slope (%)	N/A
	X Walk 1 X Slope (%)	6.6		X Walk 2 X Slope (%)	N/A

N/A	Ramp inside XWalk1?	N/A	N/A	Ramp inside XWalk2?	N/A
	Road Slope (%)	N/A	N/A	Clear Space?	N/A
	Road X Slope (%)	N/A	N/A	Clear Space to XWalk (in)	N/A
N/A	Any Obstructions?	N/A	N/A	Storm Grate/Utility Hazard?	N/A
	Obstruction Type			Storm Grate/Utility Type	
		N/A			N/A
			Yes	Surface Condition? (G/P)	Good

**Remove & Replace Entire Ramp.**

Total Cost: \$ 1850.00
