# Access Compliance Report

## Public Rights-of-Way

### (Curb Ramps)

| Intersection ID: 44115 | Main Street: RUTHERGLEN_CT | Cross Street: RIDING_HILL_AV | Location: NW |

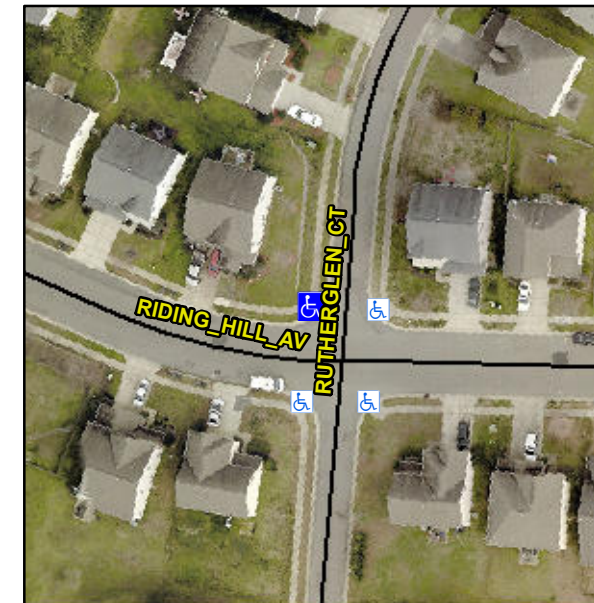
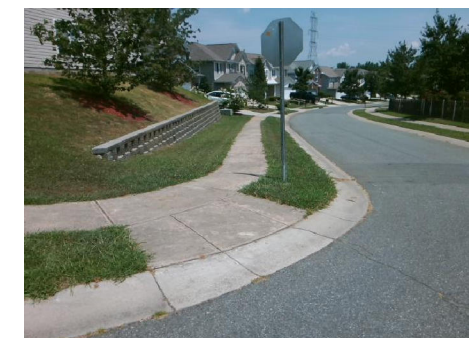
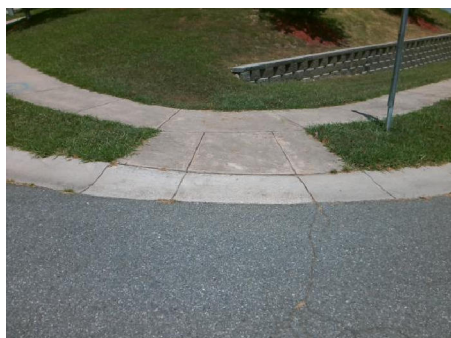
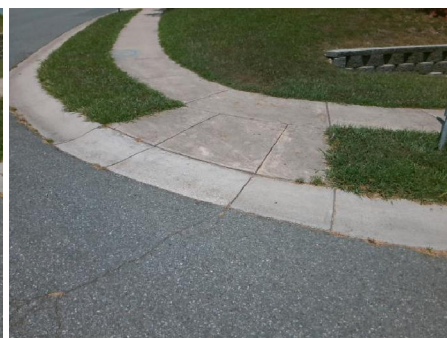
| ADA ID: 583B9E84A642 | Ramp Type: PerpDiag | Initial Pass/Fail: Fail | Overall Compliance: No<br>Severity Score: 33.75 |

**Not Found, R304.5.1, R304.2.2, R304.5.3**

| Compliance | Description | Data | Compliance | Description | Data |
|---|---|---|---|---|---|
| N/A | Ramp Length (in) | 47.0 | No | Ramp Slope (%) | 10.6 |
| No | Ramp Width (in) | 37.0 | No | Ramp XSlope (%) | 5.2 |

**Remove & Replace Curb Ramp With Two New Directional Ramps or Equivalent.**
