Access Compliance Report

Public Rights-of-Way

(Curb Ramps)

Intersection ID: 17415	Main Street: BREITLING GROVE PL	Cross Street: VISTA DR	Location: NE
ADA ID: 58422CAFA57F	Ramp Type: PerpDiag	Initial Pass/Fail: Fail	Overall Compliance: No
Severity Score: 12.5			
Codes/Mitigation Info/Possible Solution		Field Measurements/Component Compliance

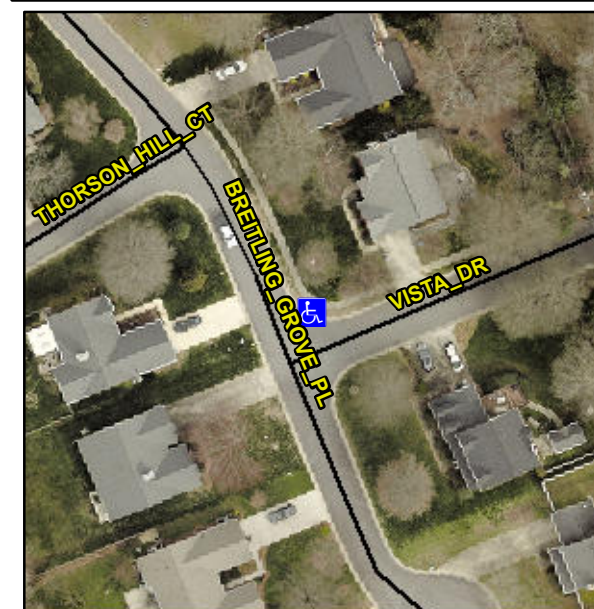
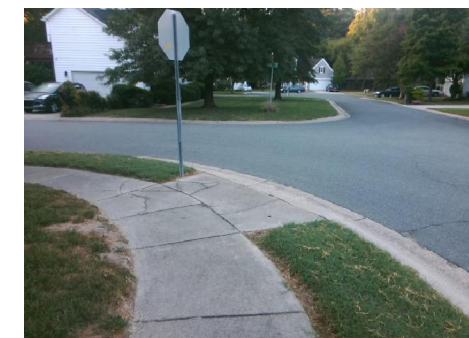
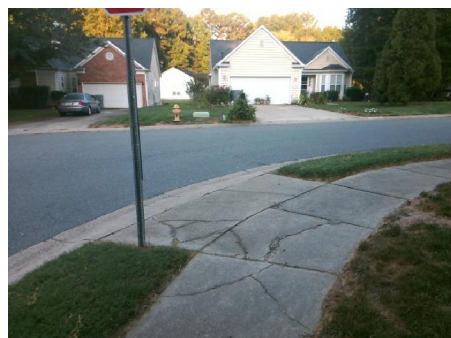
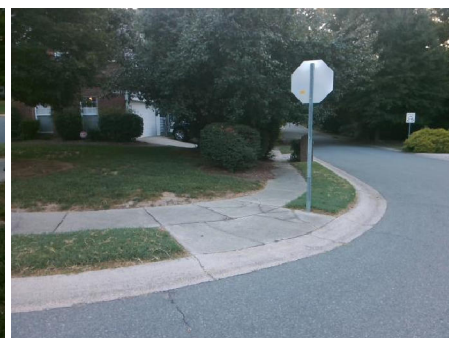
Compliance	Description	Data	Compliance	Description	Data
N/A	Ramp Length (in)	44.0	Yes	Ramp Slope (%)	7.5
Yes	Ramp Width (in)	48.0	No	Ramp XSlope (%)	5.9
N/A	Flare Type LT	N/A	N/A	Flare Type RT	N/A
N/A	Flare Slope LT (%)	N/A	N/A	Flare Slope RT (%)	N/A
N/A	Flare Traversable LT?	N/A	N/A	Flare Traversable RT?	N/A
N/A	Landing Length (in)	N/A	N/A	DWS Provided?	N/A
N/A	Landing Width (in)	N/A	N/A	DWS Contrast?	N/A
N/A	Landing Slope (%)	N/A	N/A	DWS Length (in)	N/A
N/A	Landing X Slope (%)	N/A	N/A	DWS Full Width?	N/A
N/A	Landing Curb? (Y/N)	N/A	N/A	DWS Offset (in)	N/A
N/A	Shared Landing?	N/A			
N/A	Gutter Ponding?	N/A	N/A	Gutter Slope (%)	N/A
N/A	Gutter Lip Ht (in)	N/A	N/A	Gutter X Slope (%)	N/A
N/A	Painted X Walk1?	No	N/A	Painted X Walk2?	No
	X Walk 1 Direction	To W		X Walk 2 Direction	To S
N/A	X Walk 1 Width (in)	N/A	N/A	X Walk 2 Width (in)	N/A
	X Walk 1 Slope (%)	4.6		X Walk 2 Slope (%)	1.8
	X Walk 1 X Slope (%)	3.0		X Walk 2 X Slope (%)	5.0

N/A	Ramp inside XWalk1?	N/A	N/A	Ramp inside XWalk2?	N/A
	Road Slope (%)	3.6	N/A	Clear Space?	N/A
	Road X Slope (%)	0.2	N/A	Clear Space to XWalk (in)	N/A
N/A	Any Obstructions?	N/A	N/A	Storm Grate/Utility Hazard?	N/A
	Obstruction Type			Storm Grate/Utility Type	
		N/A			N/A
		Yes		Surface Condition? (G/P)	Good

Possible Solutions:

Remove & Replace Curb Ramp With Two New Directional Ramps or Equivalent.

R304.5.3
