# Access Compliance Report

## Public Rights-of-Way

### (Curb Ramps)

Intersection ID: 14980	Main Street: DILWORTH_RD_EAST	Cross Street: EAST_BV	Location: N
ADA ID: 5873242E1D93	Ramp Type: Directional1	Initial Pass/Fail: Fail	Overall Compliance: No
Codes/Mitigation Info/Possible Solution		Field Measurements/Component Compliance

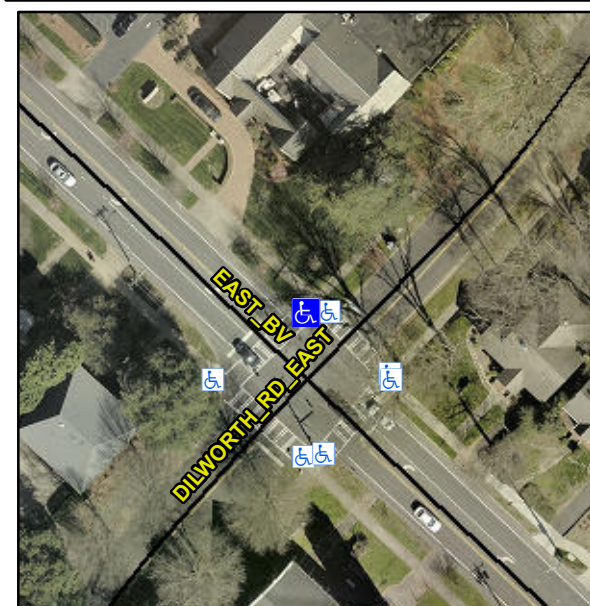
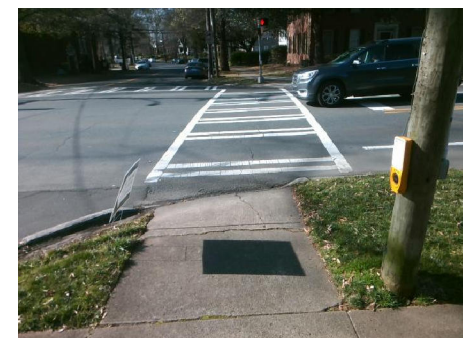
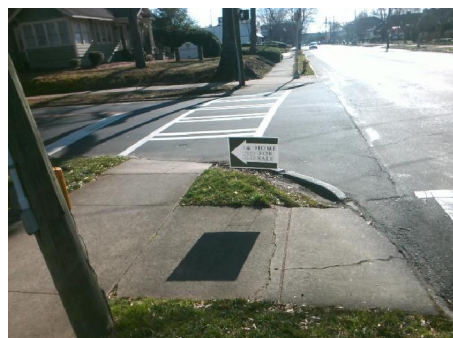
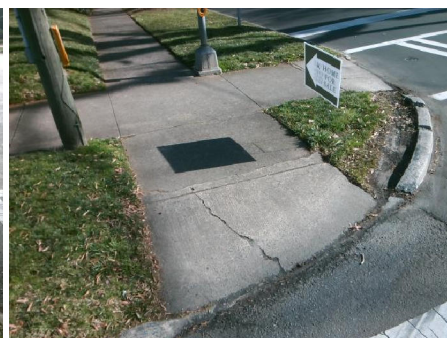
Compliance	Description	Data	Compliance	Description	Data
N/A	Ramp Length (in)	48.0	N/A	Grade Break?	N/A
Yes	Ramp Width (in)	73.0	N/A	Grade Break Slope (%)	0.0
No	Ramp Slope (%)	9.0	N/A	Grade Break XSlope (%)	0.0
No	Ramp XSlope (%)	3.7			
N/A	Flare Type LT	N/A	N/A	Flare Type RT	N/A
N/A	Flare Slope LT (%)	N/A	N/A	Flare Slope RT (%)	0.0
N/A	Flare Traversable LT?	N/A	N/A	Flare Traversable RT?	N/A
N/A	Landing Length (in)	0.0	N/A	DWS Provided?	N/A
N/A	Landing Width (in)	0.0	N/A	DWS Contrast?	N/A
N/A	Landing Slope (%)	0.0	N/A	DWS Length (in)	N/A
N/A	Landing X Slope (%)	0.0	N/A	DWS Full Width?	N/A
N/A	Landing Curb? (Y/N)	N/A	N/A	DWS Offset LT (in)	N/A
N/A	Shared Landing?	N/A	N/A	DWS Offset RT (in)	N/A
N/A	Gutter Ponding?	0.0	N/A	Gutter Slope (%)	N/A
N/A	Gutter Lip Ht (in)	0.0	N/A	Gutter X Slope (%)	N/A
N/A	Painted X Walk1?	Yes		Road Slope (%)	4.2
	X Walk 1 Direction	To SW		Road X Slope (%)	0.3
	X Walk 1 Width (in)	112.0		Clear Space?	N/A

X Walk 1 Slope (%)	4.2	N/A	Clear Space to XWalk (in)	N/A
	X Walk 1 X Slope (%)	0.3	N/A	Storm Grate/Utility Hazard?	N/A
N/A	Ramp inside XWalk1?	Yes		Storm Grate/Utility Type	
N/A	Any Obstructions?	N/A			N/A
	Obstruction Type		Yes	Surface Condition? (G/P)	Good
			N/A	Curb Slope (%)	15.9

Possible Solutions:

**Remove & Replace Entire Ramp.**

**R304.2.2, R304.5.3**
