## Access Compliance Report Public Rights-of-Way (Curb Ramps)

Intersection ID: 18941Main Street:MONROE\_RDCross Street:PAINTER\_PLLocation:NWADA ID: 587CDC8E7937Ramp Type:PerpDiagInitial Pass/Fail:FailOverall Compliance:NoSeverity Score:50

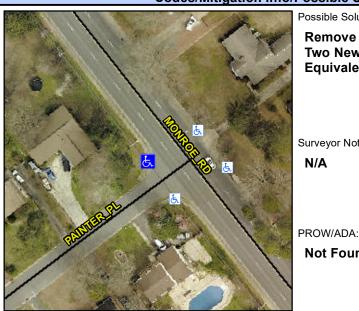
Not Found, R304.2.2, R304.5.3

Compliance Description Data Compliance Description Data No N/A Ramp Length (in) 60.0 Ramp Slope (%) 14.1 No Yes Ramp Width (in) 48.0 Ramp XSlope (%) 7.3 N/A N/A Flare Type LT N/A Flare Type RT N/A N/A N/A Flare Slope RT (%) N/A Flare Slope LT (%) N/A N/A Flare Traversable LT? N/A N/A Flare Traversable RT? N/A N/A N/A N/A **DWS Provided?** N/A Landing Length (in) N/A Landing Width (in) N/A N/A **DWS Contrast?** N/A N/A N/A Landing Slope (%) N/A DWS Length (in) N/A N/A Landing X Slope (%) N/A N/A DWS Full Width? N/A N/A Landing Curb? (Y/N) N/A N/A DWS Offset (in) N/A N/A N/A Shared Landing? N/A Gutter Ponding? N/A N/A Gutter Slope (%) N/A N/A Gutter Lip Ht (in) N/A N/A Gutter X Slope (%) N/A N/A Painted X Walk1? No N/A Painted X Walk2? No X Walk 1 Direction To SE X Walk 2 Direction To E N/A N/A X Walk 1 Width (in) X Walk 2 Width (in) N/A X Walk 1 Slope (%) 0.5 X Walk 2 Slope (%) 5.0 X Walk 1 X Slope (%) 6.3 X Walk 2 X Slope (%) 1.6 N/A N/A N/A Ramp inside XWalk2? N/A Ramp inside XWalk1? Road Slope (%) 5.9 N/A Clear Space? N/A N/A Road X Slope (%) 3.6 Clear Space to XWalk (in) N/A N/A N/A N/A Any Obstructions? Storm Grate/Utility Hazard? N/A **Obstruction Type** Storm Grate/Utility Type N/A N/A

PAINTER PL StopSign MONROE RD None Possible Solutions:

Remove & Replace Curb Ramp With
Two New Directional Ramps or
Equivalent.
