# Access Compliance Report

## Public Rights-of-Way

### (Curb Ramps)

Intersection ID: 44479	Main Street: REDDING_GLEN_AV	Cross Street: DARWICK_ST	Location: SW
ADA ID: 587EEAC9E216	Ramp Type: PerpDiag	Initial Pass/Fail: Fail	Overall Compliance: No
Severity Score: 13.75			
Codes/Mitigation Info/Possible Solution		Field Measurements/Component Compliance

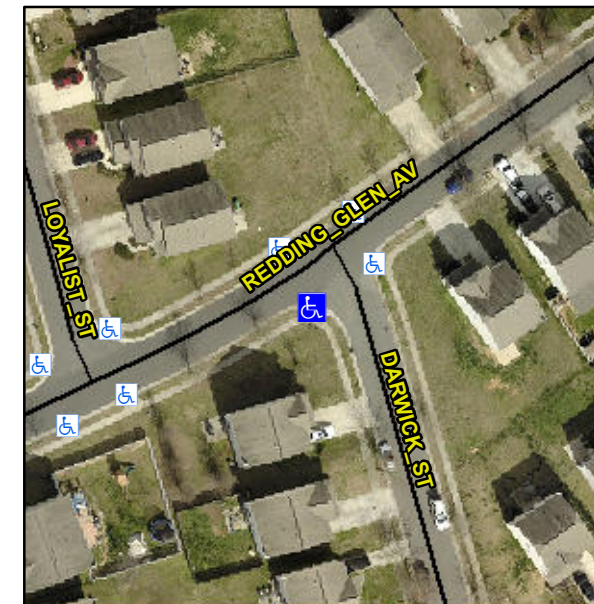
**Not Found, R304.2.2, R304.5.3**

Compliance	Description	Data	Compliance	Description	Data
N/A	Ramp Length (in)	44.5	No	Ramp Slope (%)	8.6
Yes	Ramp Width (in)	49.0	No	Ramp XSlope (%)	2.8
N/A	Flare Type LT	N/A	N/A	Flare Type RT	N/A
N/A	Flare Slope LT (%)	N/A	N/A	Flare Slope RT (%)	N/A
N/A	Flare Traversable LT?	N/A	N/A	Flare Traversable RT?	N/A
N/A	Landing Length (in)	N/A	N/A	DWS Provided?	N/A
N/A	Landing Width (in)	N/A	N/A	DWS Contrast?	N/A
N/A	Landing Slope (%)	N/A	N/A	DWS Length (in)	N/A
N/A	Landing X Slope (%)	N/A	N/A	DWS Full Width?	N/A
N/A	Landing Curb? (Y/N)	N/A	N/A	DWS Offset (in)	N/A
N/A	Shared Landing?	N/A			
N/A	Gutter Ponding?	N/A	N/A	Gutter Slope (%)	N/A
N/A	Gutter Lip Ht (in)	N/A	N/A	Gutter X Slope (%)	N/A
N/A	Painted X Walk1?	No	N/A	Painted X Walk2?	No
	X Walk 1 Direction	To E		X Walk 2 Direction	To N
N/A	X Walk 1 Width (in)	N/A	N/A	X Walk 2 Width (in)	N/A
	X Walk 1 Slope (%)	1.1		X Walk 2 Slope (%)	4.6
	X Walk 1 X Slope (%)	0.9		X Walk 2 X Slope (%)	0.8

N/A	Ramp inside XWalk1?	N/A	N/A	Ramp inside XWalk2?	N/A
	Road Slope (%)	1.5	N/A	Clear Space?	N/A
	Road X Slope (%)	0.2	N/A	Clear Space to XWalk (in)	N/A
N/A	Any Obstructions?	N/A	N/A	Storm Grate/Utility Hazard?	N/A
	Obstruction Type			Storm Grate/Utility Type	
		N/A			N/A
		Yes		Surface Condition? (G/P)	Good

**Remove & Replace Curb Ramp With Two New Directional Ramps or Equivalent.**
