# Access Compliance Report

## Public Rights-of-Way

### (Curb Ramps)

Intersection ID: 18152	Main Street: BEECHDALE_DR	Cross Street: OLD_POST_RD	Location: S
ADA ID: 588DB5BD91BF	Ramp Type: BlendTrans2	Initial Pass/Fail: Fail	Overall Compliance: No
		Severity Score: 10

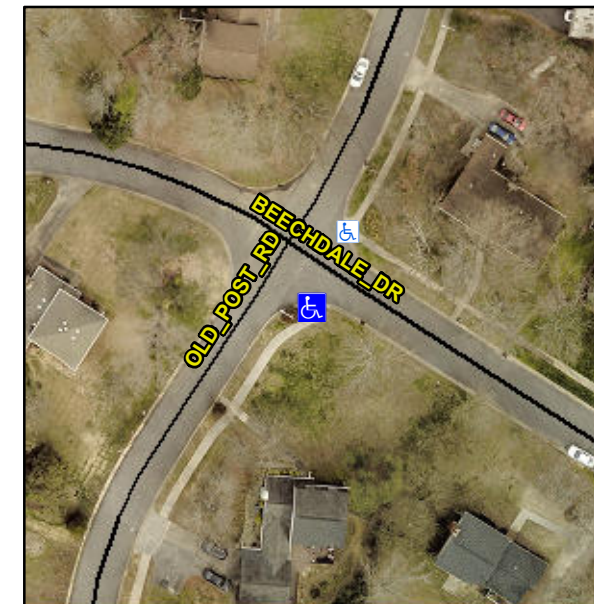
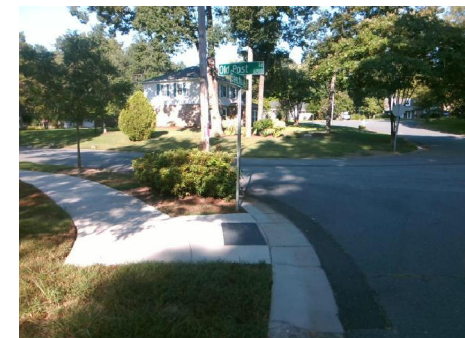
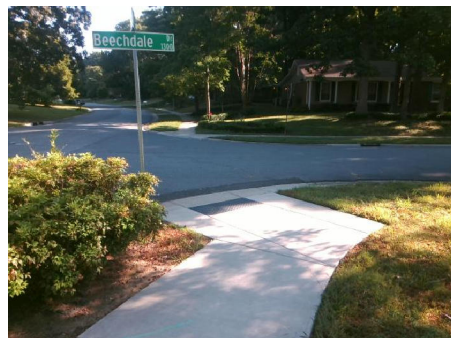
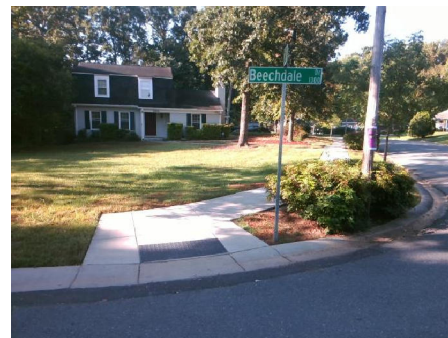
Compliance	Description	Data	Compliance	Description	Data
N/A	Ramp Length (in)	104.0	Yes	BlendTrans Slope (%)	1.2
No	Ramp Width (in)	47.0	No	BlendTrans XSlope (%)	3.8
N/A	Flare Type LT	N/A	N/A	Flare Type RT	N/A
N/A	Flare Slope LT (%)	N/A	N/A	Flare Slope RT (%)	N/A
N/A	Flare Traversable LT?	N/A	N/A	Flare Traversable RT?	N/A
N/A	Landing Length (in)	N/A	N/A	DWS Provided?	N/A
N/A	Landing Width (in)	N/A	N/A	DWS Contrast?	N/A
N/A	Landing Slope (%)	N/A	N/A	DWS Length (in)	N/A
N/A	Landing X Slope (%)	N/A	N/A	DWS Full Width?	N/A
N/A	Landing Curb? (Y/N)	N/A	N/A	DWS Offset (in)	N/A
N/A	Shared Landing?	N/A			
N/A	Gutter Ponding?	N/A	N/A	Gutter Slope (%)	N/A
N/A	Gutter Lip Ht (in)	N/A	N/A	Gutter X Slope (%)	N/A
N/A	Painted X Walk1?	No	N/A	Painted X Walk2?	No
	X Walk 1 Direction	To NE		X Walk 2 Direction	To NW
	X Walk 1 Width (in)	N/A		X Walk 2 Width (in)	N/A
	X Walk 1 Slope (%)	4.2		X Walk 2 Slope (%)	2.6
	X Walk 1 X Slope (%)	1.2		X Walk 2 X Slope (%)	2.6

N/A	Ramp inside XWalk1?	N/A	N/A	Ramp inside XWalk2?	N/A
	Road Slope (%)	0.5		Clear Space?	N/A
	Road X Slope (%)	3.7	N/A	Clear Space to XWalk (in)	N/A
N/A	Any Obstructions?	N/A	N/A	Storm Grate/Utility Hazard?	N/A
	Obstruction Type			Storm Grate/Utility Type	
		N/A			N/A
			Yes	Surface Condition? (G/P)	Good
			N/A	Curb Slope (%)	0.8

**Remove & Replace Curb Ramp With Two New Directional Ramps or Equivalent.**

**R304.5.1, R304.5.3**

Total Cost: \$ 3200.00
