## **Access Compliance Report Public Rights-of-Way** (Curb Ramps)

Intersection ID: 20251 Main Street: BURNLEY RD Cross Street: ROSECREST DR NE Location: **Overall Compliance: No Severity Score:** 0 ADA ID: 58914C6488BE Ramp Type: Combination2Diag Initial Pass/Fail: Fail

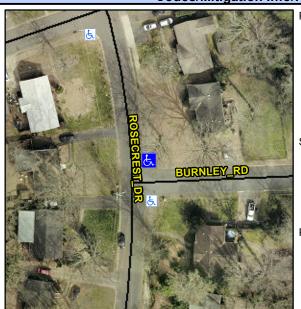
N/A No Ramp Slope LT (%) 12.5 Ramp Slope RT (%) N/A Ramp XSlope LT (%) 3.6 N/A Ramp XSlope RT (%) N/A No N/A Ramp Length (in) 84.0 Yes Ramp Slope (%) 5.2 46.0 No Ramp XSlope (%) 11.0 No Ramp Width (in) N/A Flare Type LT N/A N/A Flare Type RT N/A N/A N/A Flare Slope LT (%) N/A Flare Slope RT (%) N/A N/A Flare Traversable LT? N/A N/A Flare Traversable RT? N/A N/A Landing Length (in) N/A N/A DWS Provided? N/A N/A N/A **DWS Contrast?** N/A Landing Width (in) N/A N/A Landing Slope (%) N/A N/A DWS Length (in) N/A N/A Landing X Slope (%) N/A N/A DWS Full Width? N/A N/A Landing Curb? (Y/N) N/A N/A DWS Offset (in) N/A N/A Shared Landing? N/A N/A **Gutter Ponding?** N/A N/A Gutter Slope (%) N/A N/A Gutter Lip Ht (in) N/A N/A Gutter X Slope (%) N/A N/A N/A Painted X Walk1? No Painted X Walk2? No To W X Walk 1 Direction X Walk 2 Direction To S X Walk 1 Width (in) N/A X Walk 2 Width (in) N/A 8.0 X Walk 1 Slope (%) X Walk 2 Slope (%) 2.0 X Walk 1 X Slope (%) 4.5 X Walk 2 X Slope (%) 7.5 N/A Ramp inside XWalk1? N/A N/A Ramp inside XWalk2? N/A Road Slope (%) 5.6 Clear Space? N/A Road X Slope (%) 2.8 N/A Clear Space to XWalk (in) N/A N/A Any Obstruction? N/A **Obstruction Type** N/A N/A Storm Grate/Utility Hazard?

None ROSECREST DR StopSign **BURNLEY RD**  Possible Solutions: Remove & Replace Curb Ramp With Two New Directional Ramps or Equivalent. Surveyor Notes: N/A PROW/ADA Not Found, R304.5.1, R304.5.3, R304.3.2
