Access Compliance Report Public Rights-of-Way (Curb Ramps)

Intersection ID: 6886	Main Street: JOHN_RUSSELL_RD			Cross	Cross Street: WINGDALE_DR				Location:	SW
ADA ID: 5892035E595F	Ramp Type: Perp			Initial	Initial Pass/Fail: Fail Overall Compliance: No				o Severity Score:	10
Codes/Mitigation Info/Possible Solution				Field Measurements/Component Compliance						
	18 1.4.12	Possible Solutions:			Compliance Description			Data Compliance Description		
1 21 3 1 3 1	I A CON	Remove & Rep	lace Entire Ra	mp.	N/A	Ramp Length (in)	47.0	Yes	Ramp Slope (%)	5.9
Leads VIII III	1 Basting			•	No	Ramp Width (in)	47.0	No	Ramp XSlope (%)	3.0
and the set	A. Starte				N/A	Flare Type LT	N/A	N/A	Flare Type RT	N/A
DUN	and the second second				N/A	Flare Slope LT (%)	N/A	N/A	Flare Slope RT (%)	N/A
SOLUTION & B					N/A	Flare Traversable LT?	N/A	N/A	Flare Traversable RT?	N/A
					N/A	Landing Length (in)	N/A	N/A	DWS Provided?	N/A
		Surveyor Notes:			N/A	Landing Width (in)	N/A	N/A	DWS Contrast?	N/A

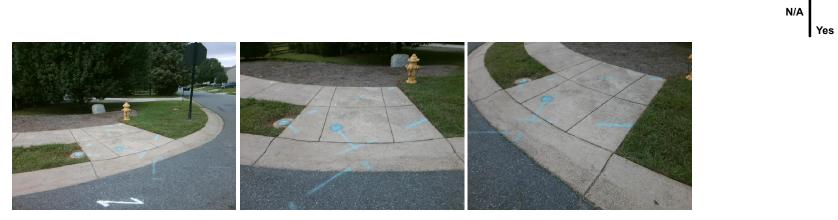
N/A			N/A	Landing Slope (%)	N/A	N/A	DWS Length (in)	N/A
					N/A	Landing X Slope (%)	N/A	N/A	DWS Full Width?	N/A
					N/A	Landing Curb? (Y/N)	N/A	N/A	DWS Offset (in)	N/A
100					N/A	Shared Landing?	N/A

6. F 22. S	PROW/ADA:			N/A	Gutter Ponding?	N/A	N/A	Gutter Slope (%)	N/A
		Not Found, R3	04.5.1. R304.5.	3	N/A	Gutter Lip Ht (in)	N/A	N/A	Gutter X Slope (%)	N/A
	Mitter &	,		-	N/A	Painted X Walk1?	No	N/A	Painted X Walk2?	N/A
						X Walk 1 Direction	To NE		X Walk 2 Direction	N/A
The Carl I was a set					N/A	X Walk 1 Width (in)	N/A	N/A	X Walk 2 Width (in)	N/A
Street 1 Name V	VINGDALE DR					X Walk 1 Slope (%)	3.3		X Walk 2 Slope (%)	N/A
Stop Condition-Street 2	StopSign					X Walk 1 X Slope (%)	5.2		X Walk 2 X Slope (%)	N/A
Street 2 Name	N/A				N/A	Ramp inside XWalk1?	N/A	N/A	Ramp inside XWalk2?	N/A
Stop Condition-Street 1	N/A					Road Slope (%)	N/A	N/A	Clear Space?	N/A
						Road X Slope (%)	N/A	N/A	Clear Space to XWalk (in)	N/A
					N/A	Any Obstructions?	N/A	N/A	Storm Grate/Utility Hazard?	N/A
		Total Cost:	\$	1850.00		Obstruction Type			Storm Grate/Utility Type	
							N/A			N/A
