## Access Compliance Report Public Rights-of-Way (Curb Ramps)

Intersection ID: 10021Main Street:S\_I-85\_RACross Street:TUCKASEEGEE\_RDLocation:WADA ID: 5894BD776003Ramp Type:PerpInitial Pass/Fail:FailOverall Compliance:NoSeverity Score:21.25

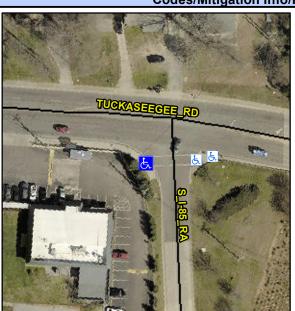
Field Measurements/Component Compliance						
Compli	ance Description	Data	Compl	iance Description	Data	
N/A	Ramp Length (in)	80.0	No	Ramp Slope (%)	8.4	
No	Ramp Width (in)	47.0	Yes	Ramp XSlope (%)	1.9	
N/A	Flare Type LT	N/A	N/A	Flare Type RT	N/A	
N/A	Flare Slope LT (%)	N/A	N/A	Flare Slope RT (%)	N/A	
N/A	Flare Traversable LT?	N/A	N/A	Flare Traversable RT?	N/A	
N/A	Landing Length (in)	N/A	N/A	DWS Provided?	N/A	
N/A	Landing Width (in)	N/A	N/A	DWS Contrast?	N/A	
N/A	Landing Slope (%)	N/A	N/A	DWS Length (in)	N/A	
N/A	Landing X Slope (%)	N/A	N/A	DWS Full Width?	N/A	
N/A	Landing Curb? (Y/N)	N/A	N/A	DWS Offset (in)	N/A	
N/A	Shared Landing?	N/A				
N/A	Gutter Ponding?	N/A	N/A	Gutter Slope (%)	N/A	
N/A	Gutter Lip Ht (in)	N/A	N/A	Gutter X Slope (%)	N/A	
N/A	Painted X Walk1?	Yes	N/A	Painted X Walk2?	N/A	
	X Walk 1 Direction	To E		X Walk 2 Direction	N/A	
N/A	X Walk 1 Width (in)	112.0	N/A	X Walk 2 Width (in)	N/A	
	X Walk 1 Slope (%)	3.8		X Walk 2 Slope (%)	N/A

X Walk 1 X Slope (%)	4.0		X Walk 2 X Slope (%)	N/A	
N/A	Ramp inside XWalk1?	Yes	N/A	Ramp inside XWalk2?	N/A	
	Road Slope (%)	N/A	N/A	Clear Space?	N/A	
	Road X Slope (%)	N/A	N/A	Clear Space to XWalk (in)	N/A	
N/A	Any Obstructions?	N/A	N/A	Storm Grate/Utility Hazard?	N/A	
	Obstruction Type			Storm Grate/Utility Type		
		N/A			N/A	
			Yes	Surface Condition? (G/P)	Good

7/POSSIDIE SOIULIOII	
Possible Solutions:	Comp
Remove & Replace Entire Ramp.	N/A
	No
	N/A
	N/A
	N/A
	N/A
Surveyor Notes:	N/A
N/A	N/A
	N/A
	N/A
	N/A
PROW/ADA:	N/A
Not Found, R304.5.1, R304.2.2	N/A
	N/A
	N/A
	N/A
