## **Access Compliance Report Public Rights-of-Way** (Curb Ramps)

Intersection ID: 14655 Main Street: CAMERON AV Cross Street: E 5TH ST Location: S

Initial Pass/Fail: Fail **Overall Compliance: No Severity Score: ADA ID: 589EB280CD7C** Ramp Type: BlendTrans1 8.75

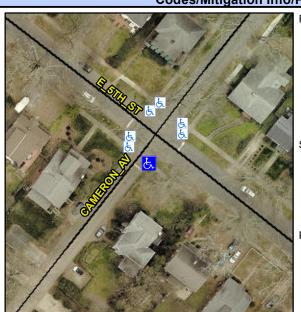
E 5TH ST StopSign **CAMERON AV** StopSign Possible Solutions: Remove & Replace Curb Ramp With Two New Directional Ramps or Equivalent. Surveyor Notes: N/A PROW/ADA: Not Found, R304.5.1

Total Cost: 3200.00 Compliance Description Data Compliance Description Data Yes N/A Ramp Length (in) 58.0 BlendTrans Slope (%) 2.4 Yes No Ramp Width (in) 42.0 BlendTrans XSlope (%) 1.6 N/A Flare Type RT N/A Flare Type LT N/A N/A N/A N/A N/A Flare Slope RT (%) N/A Flare Slope LT (%) N/A Flare Traversable LT? N/A N/A Flare Traversable RT? N/A N/A N/A N/A **DWS Provided?** N/A Landing Length (in) N/A Landing Width (in) N/A N/A **DWS Contrast?** N/A N/A N/A N/A Landing Slope (%) DWS Length (in) N/A N/A Landing X Slope (%) N/A N/A DWS Full Width? N/A N/A Landing Curb? (Y/N) N/A N/A DWS Offset (in) N/A N/A N/A Shared Landing? N/A **Gutter Ponding?** N/A N/A Gutter Slope (%) N/A N/A Gutter Lip Ht (in) N/A N/A Gutter X Slope (%) N/A N/A Painted X Walk1? No N/A Painted X Walk2? No X Walk 1 Direction To NE X Walk 2 Direction To NW N/A X Walk 1 Width (in) X Walk 2 Width (in) N/A X Walk 1 Slope (%) 2.7 X Walk 2 Slope (%) 4.2 X Walk 1 X Slope (%) 3.9 X Walk 2 X Slope (%) 2.5 N/A N/A Ramp inside XWalk2? N/A N/A Ramp inside XWalk1? Road Slope (%) 1.8 Clear Space? N/A Road X Slope (%) N/A N/A
