Intersection ID: 28237		Main Street: HIGHGROVE_ST		Cross Street: SOCIETY_ST		Location:		NW	
ADA ID: 58BB3C1F6357		Ramp Type: PerpDiag		Initial Pass/Fail: Fail		Overall Compliance: No		Severity Score: 33.75	
Codes/Mitigation Info/Possible Solution				Field Measurements/Component Compliance					
<div><div><p>Aerial photograph of the intersection of Society St and Highgrove St. The streets are labeled in yellow. Blue wheelchair icons indicate accessible curb ramp locations at all four corners.</p></div><div><p>Possible Solutions: <b>Remove &amp; Replace Curb Ramp With Two New Directional Ramps or Equivalent.</b></p><p>Surveyor Notes: <b>N/A</b></p><p>PROW/ADA: <b>Not Found, R304.5.1, R304.2.2</b></p></div></div>				Compliance	Description	Data	Compliance	Description	Data
				N/A	Ramp Length (in)	93.0	No	Ramp Slope (%)	13.9
				No	Ramp Width (in)	46.0	Yes	Ramp XSlope (%)	1.6
				N/A	Flare Type LT	N/A	N/A	Flare Type RT	N/A

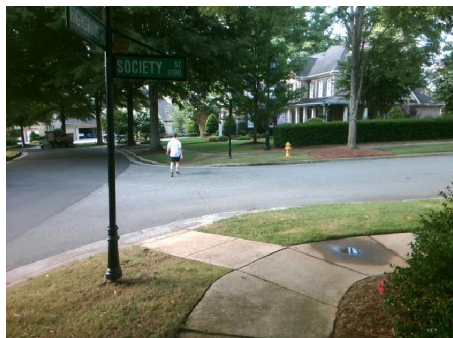
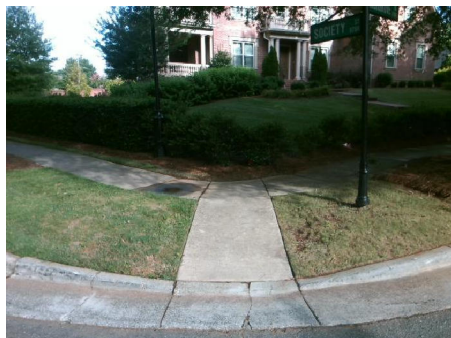
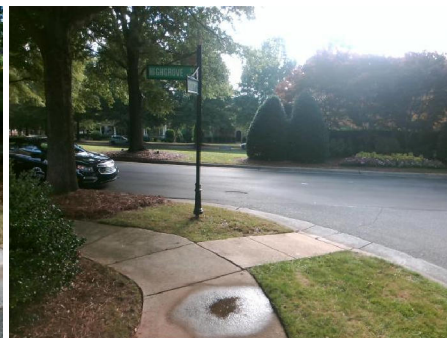
N/A	Flare Slope LT (%)	N/A	N/A	Flare Slope RT (%)	N/A
				N/A	Flare Traversable LT?	N/A	N/A	Flare Traversable RT?	N/A
				N/A	Landing Length (in)	N/A	N/A	DWS Provided?	N/A
				N/A	Landing Width (in)	N/A	N/A	DWS Contrast?	N/A
				N/A	Landing Slope (%)	N/A	N/A	DWS Length (in)	N/A
				N/A	Landing X Slope (%)	N/A	N/A	DWS Full Width?	N/A
				N/A	Landing Curb? (Y/N)	N/A	N/A	DWS Offset (in)	N/A
				N/A	Shared Landing?	N/A			
				N/A	Gutter Ponding?	N/A	N/A	Gutter Slope (%)	N/A
				N/A	Gutter Lip Ht (in)	0.5	N/A	Gutter X Slope (%)	N/A
				N/A	Painted X Walk1?	No	N/A	Painted X Walk2?	No
					X Walk 1 Direction	To SE		X Walk 2 Direction	To NE
				N/A	X Walk 1 Width (in)	N/A	N/A	X Walk 2 Width (in)	N/A
					X Walk 1 Slope (%)	0.8		X Walk 2 Slope (%)	2.3
					X Walk 1 X Slope (%)	1.9		X Walk 2 X Slope (%)	0.3
				N/A	Ramp inside XWalk1?	N/A	N/A	Ramp inside XWalk2?	N/A
					Road Slope (%)	1.6	N/A	Clear Space?	N/A

Road X Slope (%)	1.9	N/A	Clear Space to XWalk (in)	N/A
N/A	Any Obstructions?	N/A	N/A	Storm Grate/Utility Hazard?	N/A				
Total Cost: \$ 3200.00					Obstruction Type			Storm Grate/Utility Type	
						N/A			N/A
						Yes	Surface Condition? (G/P)	Good
