Access Compliance Report

Public Rights-of-Way

(Curb Ramps)

| Intersection ID: 13046 | Main Street: CENTRAL_AV | Cross Street: LAMAR_AV | Location: SW |

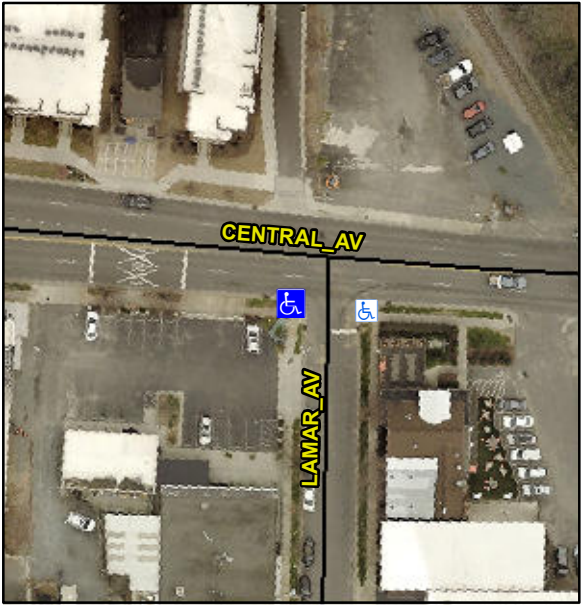
| ADA ID: 58D8E8CFCE44 | Ramp Type: Perp | Initial Pass/Fail: Fail | Overall Compliance: No |

| Codes/Mitigation Info/Possible Solution | | | Field Measurements/Component Compliance | | |
|---|---|--|---|---|---|
| | Remove & Replace Entire Ramp. | | No | Ramp Length (in) | 99.0 |
| <p>Surveyor Notes:</p> <p>N/A</p> <p>PROW/ADA:</p> <p>Not Found, R304.2.2, R304.5.3</p> | | | N/A | Flare Type RT | N/A |
| | | | N/A | Gutter Ponding? | Yes |

| Codes/Mitigation Info/Possible Solution | | | Field Measurements/Component Compliance | | |
|---|---|--|---|---|---|
| | Possible Solutions: | | Compliance | Description | Data |
| <p>Total Cost:</p> <p>\$ 1850.00</p> | | | | Obstruction Type | |
