Access Compliance Report

Public Rights-of-Way

(Curb Ramps)

Intersection ID: 51539	Main Street: TRIEG_DR	Cross Street: GLENBURN_LN	Location:	N
ADA ID: 58D91597F294	Ramp Type: PerpDiag	Initial Pass/Fail: Fail	Overall Compliance: No	Severity Score: 8.75
Codes/Mitigation Info/Possible Solution		Field Measurements/Component Compliance

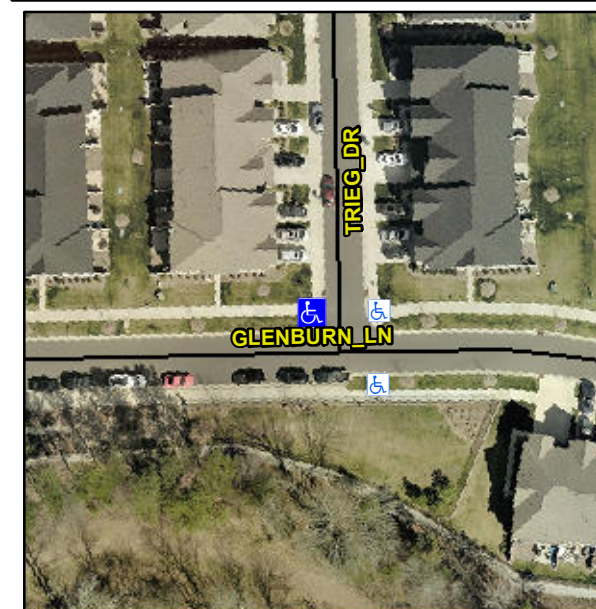
Not Found, R304.5.1

Compliance	Description	Data	Compliance	Description	Data
N/A	Ramp Length (in)	62.0	Yes	Ramp Slope (%)	5.7
No	Ramp Width (in)	47.0	Yes	Ramp XSlope (%)	1.6
N/A	Flare Type LT	N/A	N/A	Flare Type RT	N/A
N/A	Flare Slope LT (%)	N/A	N/A	Flare Slope RT (%)	N/A
N/A	Flare Traversable LT?	N/A	N/A	Flare Traversable RT?	N/A
N/A	Landing Length (in)	N/A	N/A	DWS Provided?	N/A
N/A	Landing Width (in)	N/A	N/A	DWS Contrast?	N/A
N/A	Landing Slope (%)	N/A	N/A	DWS Length (in)	N/A
N/A	Landing X Slope (%)	N/A	N/A	DWS Full Width?	N/A
N/A	Landing Curb? (Y/N)	N/A	N/A	DWS Offset (in)	N/A
N/A	Shared Landing?	N/A			
N/A	Gutter Ponding?	N/A	N/A	Gutter Slope (%)	N/A
N/A	Gutter Lip Ht (in)	N/A	N/A	Gutter X Slope (%)	N/A
N/A	Painted X Walk1?	No	N/A	Painted X Walk2?	No
	X Walk 1 Direction	To E		X Walk 2 Direction	To S
N/A	X Walk 1 Width (in)	N/A	N/A	X Walk 2 Width (in)	N/A
	X Walk 1 Slope (%)	1.1		X Walk 2 Slope (%)	0.8
	X Walk 1 X Slope (%)	0.4		X Walk 2 X Slope (%)	2.6

N/A	Ramp inside XWalk1?	N/A	N/A	Ramp inside XWalk2?	N/A
	Road Slope (%)	1.0	N/A	Clear Space?	N/A
	Road X Slope (%)	6.1	N/A	Clear Space to XWalk (in)	N/A
N/A	Any Obstructions?	N/A	N/A	Storm Grate/Utility Hazard?	N/A
	Obstruction Type			Storm Grate/Utility Type	
		N/A			N/A
			Yes	Surface Condition? (G/P)	Good

Remove & Replace Curb Ramp With Two New Directional Ramps or Equivalent.
