Access Compliance Report

Public Rights-of-Way

(Curb Ramps)

Intersection ID: 8592	Main Street: PERIWINKLE_HILL_AV	Cross Street: IKEA_BV	Location: W
ADA ID: 58DCD93810FF	Ramp Type: Perp	Initial Pass/Fail: Fail	Overall Compliance: No
Severity Score: 13.75			
Codes/Mitigation Info/Possible Solution		Field Measurements/Component Compliance

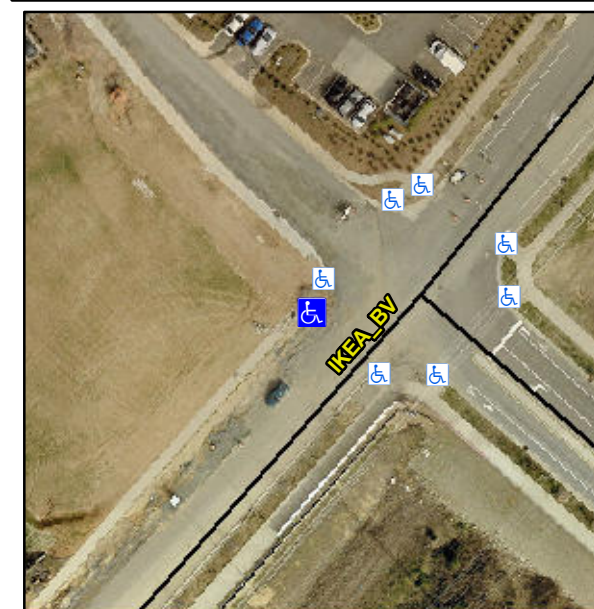
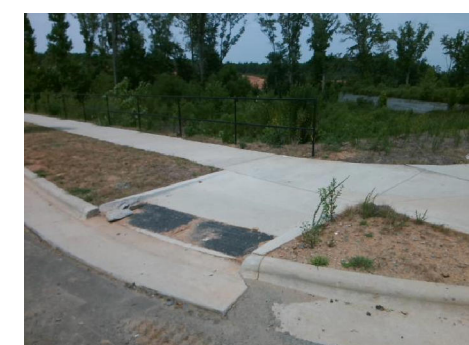
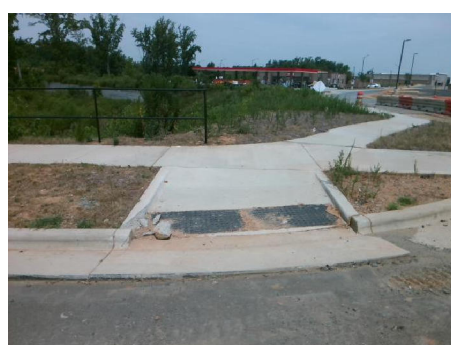
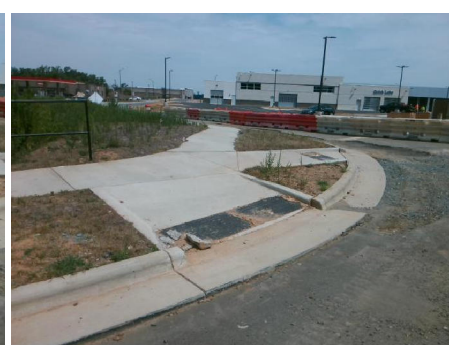
Not Found, R304.2.2, R304.5.3

Compliance	Description	Data	Compliance	Description	Data
N/A	Ramp Length (in)	78.0	No	Ramp Slope (%)	8.9
Yes	Ramp Width (in)	93.0	No	Ramp XSlope (%)	2.8
N/A	Flare Type LT	N/A	N/A	Flare Type RT	N/A
N/A	Flare Slope LT (%)	N/A	N/A	Flare Slope RT (%)	N/A
N/A	Flare Traversable LT?	N/A	N/A	Flare Traversable RT?	N/A
N/A	Landing Length (in)	N/A	N/A	DWS Provided?	N/A
N/A	Landing Width (in)	N/A	N/A	DWS Contrast?	N/A
N/A	Landing Slope (%)	N/A	N/A	DWS Length (in)	N/A
N/A	Landing X Slope (%)	N/A	N/A	DWS Full Width?	N/A
N/A	Landing Curb? (Y/N)	N/A	N/A	DWS Offset (in)	N/A
N/A	Shared Landing?	N/A			
N/A	Gutter Ponding?	N/A	N/A	Gutter Slope (%)	N/A
N/A	Gutter Lip Ht (in)	1.0	N/A	Gutter X Slope (%)	N/A
N/A	Painted X Walk1?	No	N/A	Painted X Walk2?	N/A
	X Walk 1 Direction	To SE		X Walk 2 Direction	N/A
N/A	X Walk 1 Width (in)	N/A	N/A	X Walk 2 Width (in)	N/A
	X Walk 1 Slope (%)	5.6		X Walk 2 Slope (%)	N/A
	X Walk 1 X Slope (%)	4.5		X Walk 2 X Slope (%)	N/A

N/A	Ramp inside XWalk1?	N/A	N/A	Ramp inside XWalk2?	N/A
	Road Slope (%)	N/A	N/A	Clear Space?	N/A
	Road X Slope (%)	N/A	N/A	Clear Space to XWalk (in)	N/A
N/A	Any Obstructions?	N/A	N/A	Storm Grate/Utility Hazard?	N/A
	Obstruction Type			Storm Grate/Utility Type	
		N/A			N/A
			Yes	Surface Condition? (G/P)	Good

Possible Solutions:

Remove & Replace Entire Ramp.
