Access Compliance Report

Public Rights-of-Way

(Curb Ramps)

Intersection ID: 46494	Main Street: BONNYBRIDGE_CT	Cross Street: BERE_ISLAND_DR	Location: NW
ADA ID: 58ECA5B56347	Ramp Type: Perp	Initial Pass/Fail: Fail	Overall Compliance: No Severity Score: 13.75

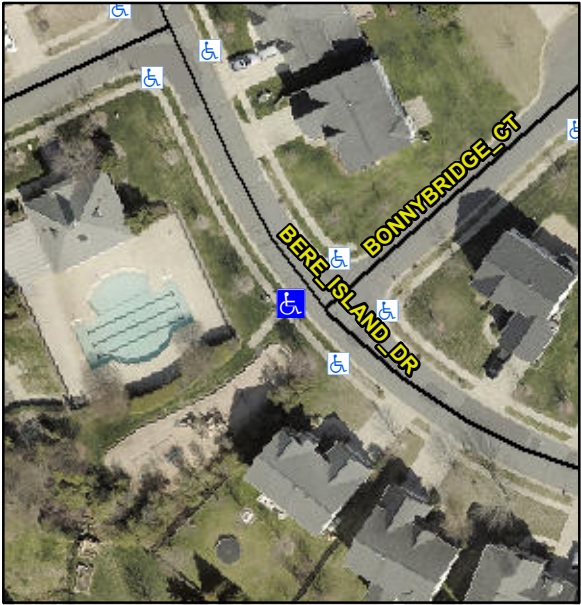
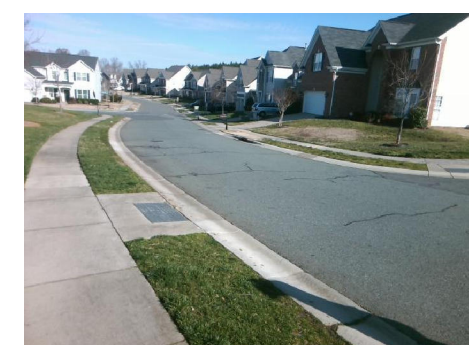
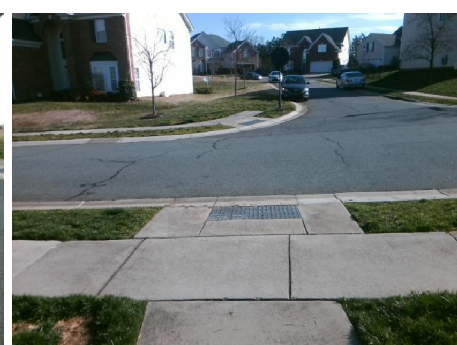
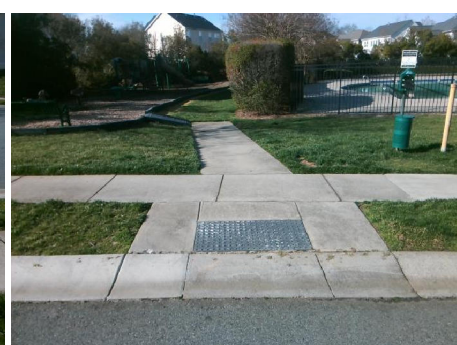
Possible Solutions:		Compliance	Description	Data
	Remove & Replace Entire Ramp.		No	Ramp Length (in)	47.0
			Yes	Ramp Width (in)	48.0
			N/A	Flare Type LT	N/A
			N/A	Flare Slope LT (%)	N/A
			N/A	Flare Traversable LT?	N/A
			N/A	Landing Length (in)	N/A
			N/A	Landing Width (in)	N/A
			N/A	Landing Slope (%)	N/A
			N/A	Landing X Slope (%)	N/A
<p>Surveyor Notes:</p> <p>N/A</p> <p>PROW/ADA:</p> <p>Not Found, R304.2.2</p>			N/A	Flare Type RT	N/A
			N/A	Flare Slope RT (%)	N/A
			N/A	Flare Traversable RT?	N/A
			N/A	DWS Provided?	N/A
			N/A	DWS Contrast?	N/A
			N/A	DWS Length (in)	N/A
			N/A	DWS Full Width?	N/A
			N/A	DWS Offset (in)	N/A
			N/A	Shared Landing?	N/A
			N/A	Gutter Ponding?	N/A
			N/A	Gutter Lip Ht (in)	N/A
			N/A	Painted X Walk1?	No
				X Walk 1 Direction	To NE
			N/A	X Walk 1 Width (in)	N/A
				X Walk 1 Slope (%)	2.1
				X Walk 1 X Slope (%)	5.0

N/A	Ramp inside XWalk1?	N/A
			N/A	Road Slope (%)	N/A
			N/A	Road X Slope (%)	N/A
			N/A	Any Obstructions?	N/A
Total Cost:		\$ 1850.00		Obstruction Type	
			N/A		
			N/A	Clear Space?	N/A
			N/A	Clear Space to XWalk (in)	N/A
			N/A	Storm Grate/Utility Hazard?	N/A
				Storm Grate/Utility Type	
			N/A		N/A
			Yes	Surface Condition? (G/P)	Good
