Access Compliance Report

Public Rights-of-Way

(Curb Ramps)

Intersection ID: 11815	Main Street: N_POPLAR_ST	Cross Street: W_7TH_ST	Location: W
ADA ID: 58F1F7AF964D	Ramp Type: PerpDiag	Initial Pass/Fail: Fail	Overall Compliance: No
			Severity Score: 26.25

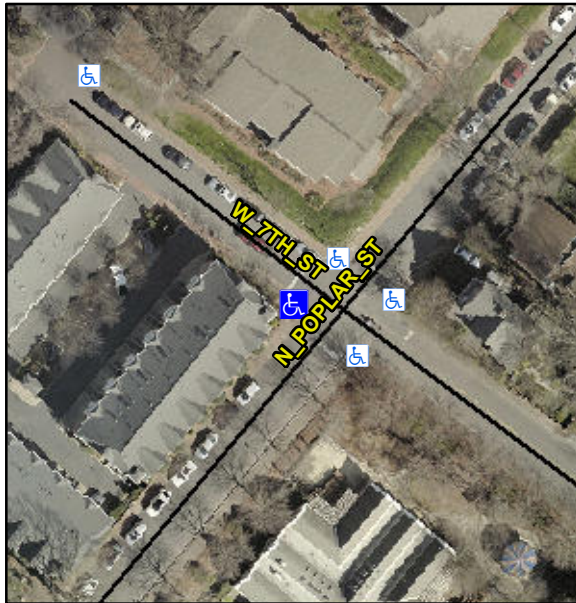
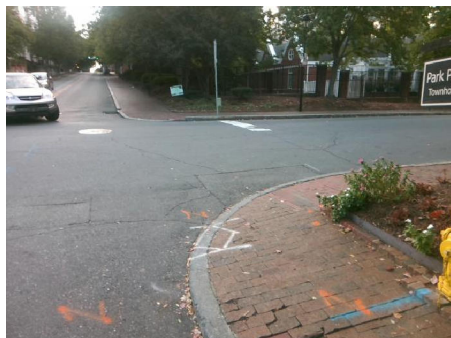
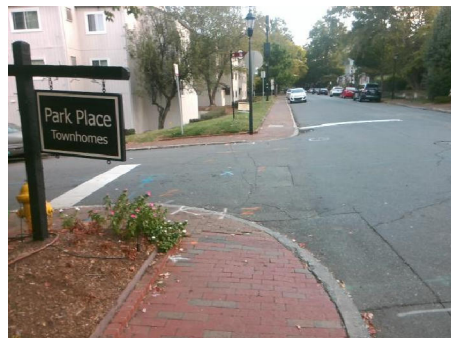
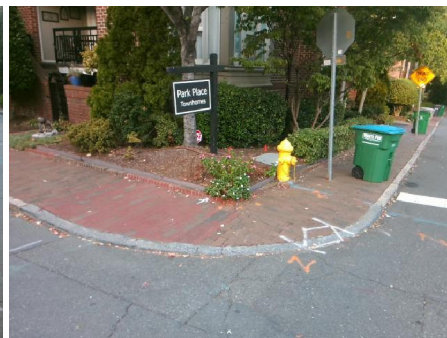
Not Found, R304.2.2, R304.5.3

Compliance	Description	Data	Compliance	Description	Data
N/A	Ramp Length (in)	39.0	No	Ramp Slope (%)	12.2
Yes	Ramp Width (in)	48.0	No	Ramp XSlope (%)	4.8
N/A	Flare Type LT	N/A	N/A	Flare Type RT	N/A
N/A	Flare Slope LT (%)	N/A	N/A	Flare Slope RT (%)	N/A
N/A	Flare Traversable LT?	N/A	N/A	Flare Traversable RT?	N/A
N/A	Landing Length (in)	N/A	N/A	DWS Provided?	N/A
N/A	Landing Width (in)	N/A	N/A	DWS Contrast?	N/A
N/A	Landing Slope (%)	N/A	N/A	DWS Length (in)	N/A
N/A	Landing X Slope (%)	N/A	N/A	DWS Full Width?	N/A
N/A	Landing Curb? (Y/N)	N/A	N/A	DWS Offset (in)	N/A
N/A	Shared Landing?	N/A			
N/A	Gutter Ponding?	N/A	N/A	Gutter Slope (%)	N/A
N/A	Gutter Lip Ht (in)	N/A	N/A	Gutter X Slope (%)	N/A
N/A	Painted X Walk1?	No	N/A	Painted X Walk2?	No
	X Walk 1 Direction	To SE		X Walk 2 Direction	To NE
N/A	X Walk 1 Width (in)	N/A	N/A	X Walk 2 Width (in)	N/A
	X Walk 1 Slope (%)	6.7		X Walk 2 Slope (%)	4.0
	X Walk 1 X Slope (%)	2.2		X Walk 2 X Slope (%)	2.9

N/A	Ramp inside XWalk1?	N/A	N/A	Ramp inside XWalk2?	N/A
	Road Slope (%)	2.0	N/A	Clear Space?	N/A
	Road X Slope (%)	5.6	N/A	Clear Space to XWalk (in)	N/A
N/A	Any Obstructions?	N/A	N/A	Storm Grate/Utility Hazard?	N/A
	Obstruction Type			Storm Grate/Utility Type	
		N/A			N/A
			Yes	Surface Condition? (G/P)	Good

Remove & Replace Curb Ramp With Two New Directional Ramps or Equivalent.
