## Access Compliance Report Public Rights-of-Way (Curb Ramps)

Intersection ID: 42705	6 Main Street: DADK DD			oot:		Location:	SE		
	Main Street: PARK_RD			Cross Street: SHARON_RD					
ADA ID: 58F6FB8964A3 Ramp Type: IslandPerp			Initial Pass/Fail: Fail Overall Compliance: No					o Severity Score:	12.5
Codes/Mitigation Info/Possible Solution			Field Measurements/Component Compliance

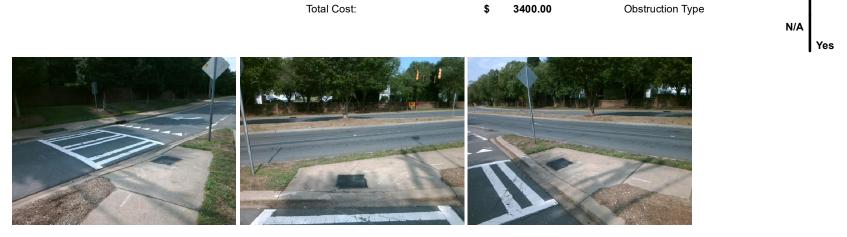
6. N		Possible Solutions:	Compliance Description			Data	Data Compliance Description		Data
	HARA	Remove & Replace Entire Ramp.	N/	/ <b>A</b>	Ramp Length (in)	71.0	No	Ramp Slope (%)	9.6
State And	A Star		Ye	es	Ramp Width (in)	48.0	Yes	Ramp XSlope (%)	1.7
	1 Second		N/.	/ <b>A</b>	Flare Type LT	N/A	N/A	Flare Type RT	N/A
	10 A 3 4		N/	/ <b>A</b>	Flare Slope LT (%)	N/A	N/A	Flare Slope RT (%)	N/A
			N/	/ <b>A</b>	Flare Traversable LT?	N/A	N/A	Flare Traversable RT?	N/A
			N/	/ <b>A</b>	Landing Length (in)	N/A	N/A	DWS Provided?	N/A
	Mar at	Surveyor Notes:	N/	/ <b>A</b>	Landing Width (in)	N/A	N/A	DWS Contrast?	N/A
	ALC: NO.	N/A	N/	/ <b>A</b>	Landing Slope (%)	N/A	N/A	DWS Length (in)	N/A
	the state of		N/	/ <b>A</b>	Landing X Slope (%)	N/A	N/A	DWS Full Width?	N/A
	and the second		N/	/ <b>A</b>	Landing Curb? (Y/N)	N/A	N/A	DWS Offset (in)	N/A
	and the f		N/	/ <b>A</b>	Shared Landing?	N/A			
	Contract -	PROW/ADA:	N/	/ <b>A</b>	Gutter Ponding?	N/A	N/A	Gutter Slope (%)	N/A

Car I	Not Found, R304.2.2	N/.	/ <b>A</b>	Gutter Lip Ht (in)	N/A	N/A	Gutter X Slope (%)	N/A
LAS BE CONTRACT	S Free L		N/	/ <b>A</b>	Painted X Walk1?	Yes	N/A	Painted X Walk2?	N/A
					X Walk 1 Direction	To SE		X Walk 2 Direction	N/A
			N/	/ <b>A</b>	X Walk 1 Width (in)	109.0	N/A	X Walk 2 Width (in)	N/A
Street 1 Name	PARK RD	_			X Walk 1 Slope (%)	4.8		X Walk 2 Slope (%)	N/A
Stop Condition-Street 2	YieldSign				X Walk 1 X Slope (%)	1.9		X Walk 2 X Slope (%)	N/A
Street 2 Name	N/A		N/	/ <b>A</b>	Ramp inside XWalk1?	Yes	N/A	Ramp inside XWalk2?	N/A
Stop Condition-Street 1	N/A				Road Slope (%)	N/A	N/A	Clear Space?	N/A
					Road X Slope (%)	N/A	N/A	Clear Space to XWalk (in)	N/A
			N/	/ <b>A</b>	Any Obstructions?	N/A	N/A	Storm Grate/Utility Hazard?	N/A
		Total Cost: \$ 3	400.00		Obstruction Type			Storm Grate/Utility Type	
						N/A			N/A
