Access Compliance Report

Public Rights-of-Way

(Curb Ramps)

Intersection ID: 27236	Main Street: BALLANTYNE CORPORATE PL	Cross Street: BRIXHAM HILL AV	Location: NE
ADA ID: 58FFCDBC8045	Ramp Type: Perp	Initial Pass/Fail: Fail	Overall Compliance: No
Severity Score: 13.75			
Codes/Mitigation Info/Possible Solution		Field Measurements/Component Compliance

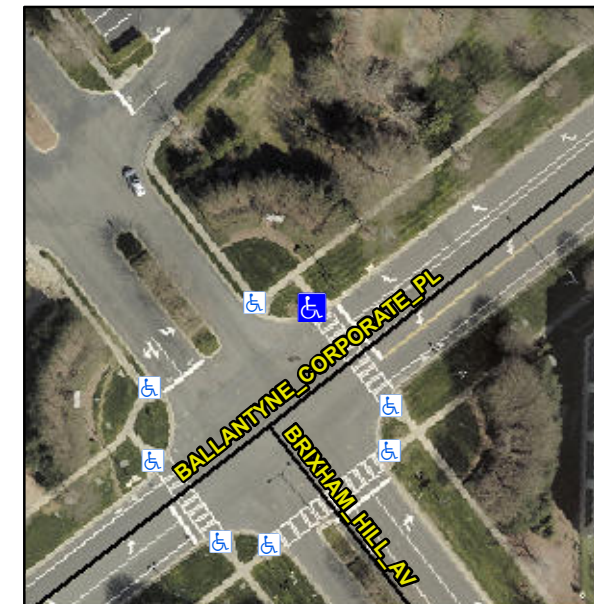
R304.2.2, R304.5.3

Compliance	Description	Data	Compliance	Description	Data
N/A	Ramp Length (in)	119.0	No	Ramp Slope (%)	8.8
Yes	Ramp Width (in)	48.0	No	Ramp XSlope (%)	2.5
N/A	Flare Type LT	N/A	N/A	Flare Type RT	N/A
N/A	Flare Slope LT (%)	N/A	N/A	Flare Slope RT (%)	N/A
N/A	Flare Traversable LT?	N/A	N/A	Flare Traversable RT?	N/A
N/A	Landing Length (in)	N/A	N/A	DWS Provided?	N/A
N/A	Landing Width (in)	N/A	N/A	DWS Contrast?	N/A
N/A	Landing Slope (%)	N/A	N/A	DWS Length (in)	N/A
N/A	Landing X Slope (%)	N/A	N/A	DWS Full Width?	N/A
N/A	Landing Curb? (Y/N)	N/A	N/A	DWS Offset (in)	N/A
N/A	Shared Landing?	N/A			
N/A	Gutter Ponding?	N/A	N/A	Gutter Slope (%)	N/A
N/A	Gutter Lip Ht (in)	N/A	N/A	Gutter X Slope (%)	N/A
N/A	Painted X Walk1?	Yes	N/A	Painted X Walk2?	N/A
	X Walk 1 Direction	To SE		X Walk 2 Direction	N/A
N/A	X Walk 1 Width (in)	112.0	N/A	X Walk 2 Width (in)	N/A
	X Walk 1 Slope (%)	2.5		X Walk 2 Slope (%)	N/A
	X Walk 1 X Slope (%)	2.8		X Walk 2 X Slope (%)	N/A

N/A	Ramp inside XWalk1?	Yes	N/A	Ramp inside XWalk2?	N/A
	Road Slope (%)	N/A	N/A	Clear Space?	N/A
	Road X Slope (%)	N/A	N/A	Clear Space to XWalk (in)	N/A
N/A	Any Obstructions?	N/A	N/A	Storm Grate/Utility Hazard?	N/A
	Obstruction Type			Storm Grate/Utility Type	
		N/A			N/A
			Yes	Surface Condition? (G/P)	Good

Remove & Replace Entire Ramp.
