Access Compliance Report Public Rights-of-Way (Curb Ramps)

Intersection ID: 32074 Main Street: SPRINGBANK LN **Cross Street: SPRINGS VILLAGE LN** Location: NW ADA ID: 5924EA7E8B78 Ramp Type: PerpDiag Initial Pass/Fail: Fail **Overall Compliance: No** Severity Score: 13.75

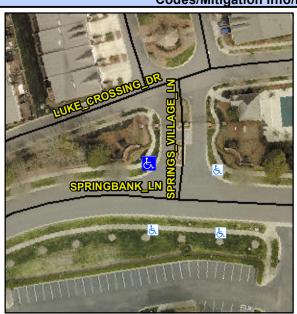
ried Measurements/Component Compnance					
Compliance Description		Data	Compliance Description		Data
N/A	Ramp Length (in)	96.0	No	Ramp Slope (%)	8.6
Yes	Ramp Width (in)	49.0	No	Ramp XSlope (%)	3.0
N/A	Flare Type LT	N/A	N/A	Flare Type RT	N/A
N/A	Flare Slope LT (%)	N/A	N/A	Flare Slope RT (%)	N/A
N/A	Flare Traversable LT?	N/A	N/A	Flare Traversable RT?	N/A
N/A	Landing Length (in)	N/A	N/A	DWS Provided?	N/A
N/A	Landing Width (in)	N/A	N/A	DWS Contrast?	N/A
N/A	Landing Slope (%)	N/A	N/A	DWS Length (in)	N/A
N/A	Landing X Slope (%)	N/A	N/A	DWS Full Width?	N/A
N/A	Landing Curb? (Y/N)	N/A	N/A	DWS Offset (in)	N/A
N/A	Shared Landing?	N/A			
N/A	Gutter Ponding?	N/A	N/A	Gutter Slope (%)	N/A
N/A	Gutter Lip Ht (in)	N/A	N/A	Gutter X Slope (%)	N/A
N/A	Painted X Walk1?	No	N/A	Painted X Walk2?	No
	X Walk 1 Direction	To S		X Walk 2 Direction	To SE
N/A	X Walk 1 Width (in)	N/A	N/A	X Walk 2 Width (in)	N/A
	X Walk 1 Slope (%)	6.1		X Walk 2 Slope (%)	0.4

X Walk 1 X Slope (%)	1.3		X Walk 2 X Slope (%)	4.9
N/A	Ramp inside XWalk1?	N/A	N/A	Ramp inside XWalk2?	N/A
	Road Slope (%)	3.6	N/A	Clear Space?	N/A
	Road X Slope (%)	4.1	N/A	Clear Space to XWalk (in)	N/A
N/A	Any Obstructions?	N/A	N/A	Storm Grate/Utility Hazard?	N/A
	Obstruction Type			Storm Grate/Utility Type	
		N/A			N/A

SPRINGBANK LN Street 1 Name Stop Condition-Street 2 None **SPRINGS VILLAGE LN** Street 2 Name Stop Condition-Street 1 StopSign Possible Solutions: Remove & Replace Curb Ramp With Two New Directional Ramps or Equivalent. Surveyor Notes: N/A PROW/ADA: R304.2.2, R304.5.3
