Access Compliance Report

Public Rights-of-Way

(Curb Ramps)

Intersection ID: 5196	Main Street: INTERFACE_LN	Cross Street: KRYSTLE_JUNE_BV	Location:	N
ADA ID: 595C3CEAA335	Ramp Type: Perp	Initial Pass/Fail: Fail	Overall Compliance: No	Severity Score: 8.75
Codes/Mitigation Info/Possible Solution		Field Measurements/Component Compliance

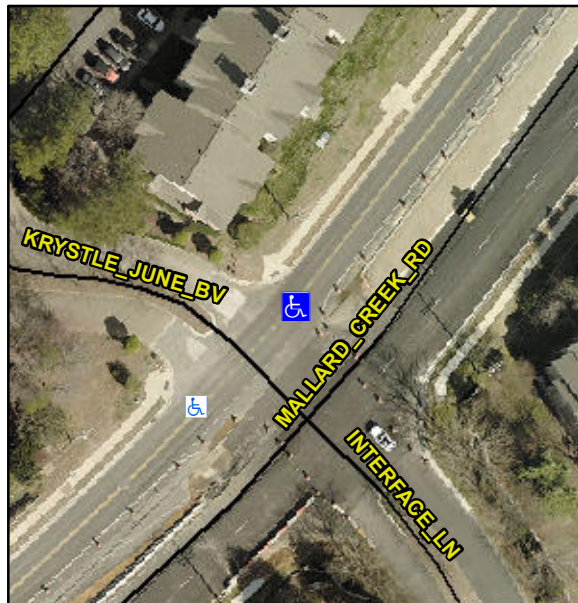
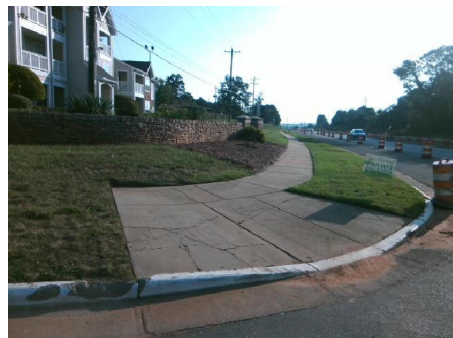
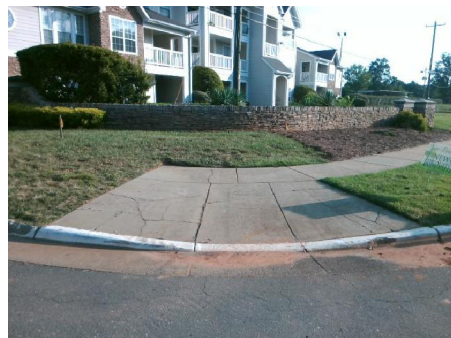
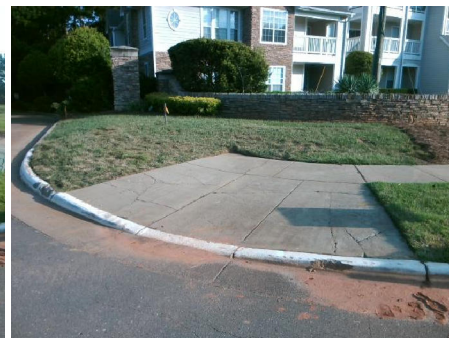
Not Found, R304.5.1

Compliance	Description	Data	Compliance	Description	Data
N/A	Ramp Length (in)	104.0	Yes	Ramp Slope (%)	6.3
No	Ramp Width (in)	43.0	Yes	Ramp XSlope (%)	0.8
N/A	Flare Type LT	N/A	N/A	Flare Type RT	N/A
N/A	Flare Slope LT (%)	N/A	N/A	Flare Slope RT (%)	N/A
N/A	Flare Traversable LT?	N/A	N/A	Flare Traversable RT?	N/A
N/A	Landing Length (in)	N/A	N/A	DWS Provided?	N/A
N/A	Landing Width (in)	N/A	N/A	DWS Contrast?	N/A
N/A	Landing Slope (%)	N/A	N/A	DWS Length (in)	N/A
N/A	Landing X Slope (%)	N/A	N/A	DWS Full Width?	N/A
N/A	Landing Curb? (Y/N)	N/A	N/A	DWS Offset (in)	N/A
N/A	Shared Landing?	N/A			
N/A	Gutter Ponding?	N/A	N/A	Gutter Slope (%)	N/A
N/A	Gutter Lip Ht (in)	N/A	N/A	Gutter X Slope (%)	N/A
N/A	Painted X Walk1?	No	N/A	Painted X Walk2?	N/A
	X Walk 1 Direction	To SW		X Walk 2 Direction	N/A
N/A	X Walk 1 Width (in)	N/A	N/A	X Walk 2 Width (in)	N/A
	X Walk 1 Slope (%)	1.1		X Walk 2 Slope (%)	N/A
	X Walk 1 X Slope (%)	0.6		X Walk 2 X Slope (%)	N/A

N/A	Ramp inside XWalk1?	N/A	N/A	Ramp inside XWalk2?	N/A
	Road Slope (%)	N/A	N/A	Clear Space?	N/A
	Road X Slope (%)	N/A	N/A	Clear Space to XWalk (in)	N/A
N/A	Any Obstructions?	N/A	N/A	Storm Grate/Utility Hazard?	N/A
	Obstruction Type			Storm Grate/Utility Type	
		N/A			N/A
			Yes	Surface Condition? (G/P)	Good

Remove & Replace Entire Ramp.

Total Cost: \$ 1850.00
