Access Compliance Report Public Rights-of-Way (Curb Ramps)

Intersection ID: 7724 Main Street: BEATTIES FORD RD Cross Street: N_I-85_EXIT_37_RA Location: SW ADA ID: 59685713EC4D Ramp Type: PerpDiag Initial Pass/Fail: Fail **Overall Compliance: No Severity Score:** 12.5

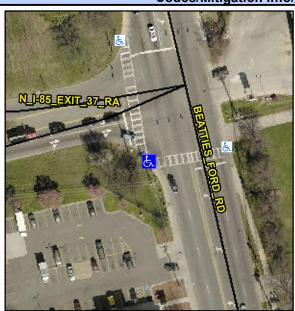
Field Measurements/Component Compliance					
Compliance Description		Data	Comp	liance Description	Data
N/A	Ramp Length (in)	62.0	No	Ramp Slope (%)	11.8
Yes	Ramp Width (in)	48.0	Yes	Ramp XSlope (%)	0.3
N/A	Flare Type LT	N/A	N/A	Flare Type RT	N/A
N/A	Flare Slope LT (%)	N/A	N/A	Flare Slope RT (%)	N/A
N/A	Flare Traversable LT?	N/A	N/A	Flare Traversable RT?	N/A
N/A	Landing Length (in)	N/A	N/A	DWS Provided?	N/A
N/A	Landing Width (in)	N/A	N/A	DWS Contrast?	N/A
N/A	Landing Slope (%)	N/A	N/A	DWS Length (in)	N/A
N/A	Landing X Slope (%)	N/A	N/A	DWS Full Width?	N/A
N/A	Landing Curb? (Y/N)	N/A	N/A	DWS Offset (in)	N/A
N/A	Shared Landing?	N/A			
N/A	Gutter Ponding?	N/A	N/A	Gutter Slope (%)	N/A
N/A	Gutter Lip Ht (in)	N/A	N/A	Gutter X Slope (%)	N/A
N/A	Painted X Walk1?	Yes	N/A	Painted X Walk2?	No
	X Walk 1 Direction	To N		X Walk 2 Direction	To E
N/A	X Walk 1 Width (in)	109.0	N/A	X Walk 2 Width (in)	N/A
	X Walk 1 Slope (%)	0.9		X Walk 2 Slope (%)	0.3

X Walk 1 X Slope (%)	0.6		X Walk 2 X Slope (%)	3.7
N/A	Ramp inside XWalk1?	Yes	N/A	Ramp inside XWalk2?	N/A
	Road Slope (%)	1.6	N/A	Clear Space?	N/A
	Road X Slope (%)	2.6	N/A	Clear Space to XWalk (in)	N/A
N/A	Any Obstructions?	N/A	N/A	Storm Grate/Utility Hazard?	N/A
	Obstruction Type			Storm Grate/Utility Type	
		N/A			N/A
			Yes	Surface Condition? (G/P)	Good

Street 1 Name **BEATTIES FORD RD** Stop Condition-Street 2 Signal Street 2 Name N I-85 EXIT 37 RA Stop Condition-Street 1 Signal Possible Solutions: **Remove & Replace Curb Ramp With Two New Directional Ramps or** Equivalent. Surveyor Notes: N/A PROW/ADA: Not Found, R304.2.2
