# Access Compliance Report

## Public Rights-of-Way

### (Curb Ramps)

Intersection ID: 14946	Main Street: DILWORTH RD WEST	Cross Street: E WORTHINGTON AV	Location: N
ADA ID: 59731CE6E152	Ramp Type: Perp	Initial Pass/Fail: Fail	Overall Compliance: No
		Severity Score: 1.25

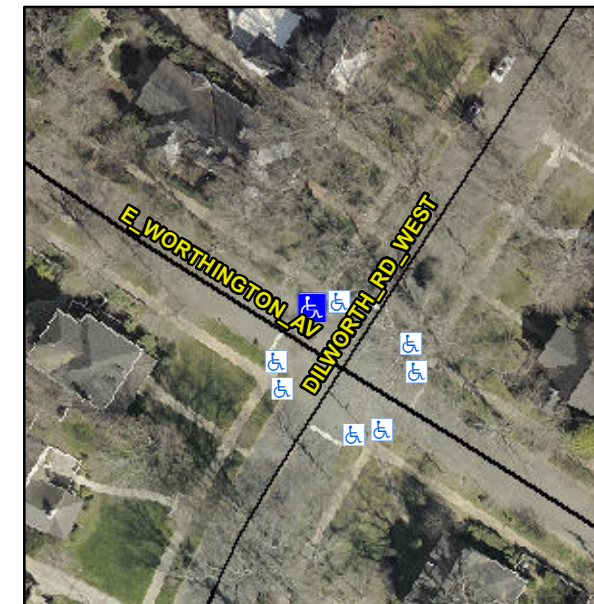
**Not Found, R304.5.3**

Compliance	Description	Data	Compliance	Description	Data
N/A	Ramp Length (in)	59.0	Yes	Ramp Slope (%)	6.7
Yes	Ramp Width (in)	48.0	No	Ramp XSlope (%)	2.2
N/A	Flare Type LT	N/A	N/A	Flare Type RT	N/A
N/A	Flare Slope LT (%)	N/A	N/A	Flare Slope RT (%)	N/A
N/A	Flare Traversable LT?	N/A	N/A	Flare Traversable RT?	N/A
N/A	Landing Length (in)	N/A	N/A	DWS Provided?	N/A
N/A	Landing Width (in)	N/A	N/A	DWS Contrast?	N/A
N/A	Landing Slope (%)	N/A	N/A	DWS Length (in)	N/A
N/A	Landing X Slope (%)	N/A	N/A	DWS Full Width?	N/A
N/A	Landing Curb? (Y/N)	N/A	N/A	DWS Offset (in)	N/A
N/A	Shared Landing?	N/A			
N/A	Gutter Ponding?	N/A	N/A	Gutter Slope (%)	N/A
N/A	Gutter Lip Ht (in)	N/A	N/A	Gutter X Slope (%)	N/A
N/A	Painted X Walk1?	No	N/A	Painted X Walk2?	N/A
	X Walk 1 Direction	To SW		X Walk 2 Direction	N/A
N/A	X Walk 1 Width (in)	N/A	N/A	X Walk 2 Width (in)	N/A
	X Walk 1 Slope (%)	3.6		X Walk 2 Slope (%)	N/A
	X Walk 1 X Slope (%)	0.6		X Walk 2 X Slope (%)	N/A

N/A	Ramp inside XWalk1?	N/A	N/A	Ramp inside XWalk2?	N/A
	Road Slope (%)	N/A	N/A	Clear Space?	N/A
	Road X Slope (%)	N/A	N/A	Clear Space to XWalk (in)	N/A
N/A	Any Obstructions?	N/A	N/A	Storm Grate/Utility Hazard?	N/A
	Obstruction Type			Storm Grate/Utility Type	
		N/A			N/A
			Yes	Surface Condition? (G/P)	Good

**Remove & Replace Entire Ramp.**

Total Cost: \$ 1850.00
