Access Compliance Report

Public Rights-of-Way

(Curb Ramps)

| Intersection ID: 45860 | Main Street: FRYE_PL | Cross Street: HENDERSON_OAKS_DR | Location: W |

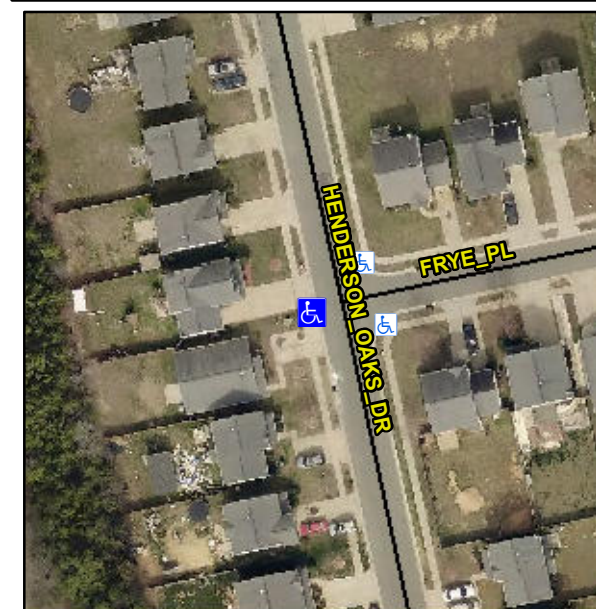
| ADA ID: 597A6D69FABD | Ramp Type: Perp | Initial Pass/Fail: Pass | Overall Compliance: No |
| Severity Score: 10.25 | | | |

| Compliance | Description | Data | Compliance | Description | Data |
|---|---|---|---|---|---|
| Yes | Landing Length (in) | 48.0 | No | DWS Provided? | No |

Possible Solutions:

Install Detectable Warning System.

PROW/ADA:

R305

Total Cost: \$ 235.00

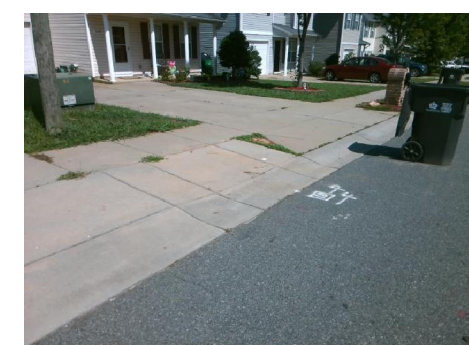
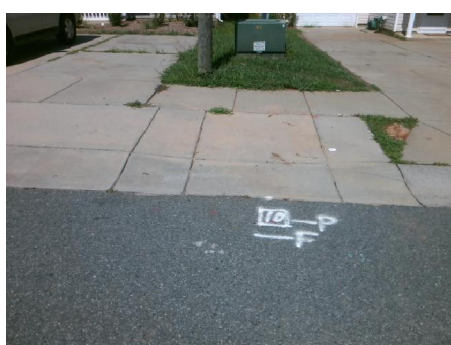
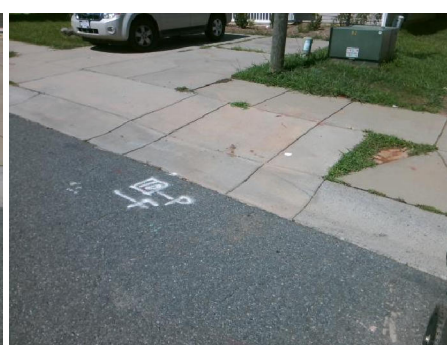
| Compliance | Description | Data | Compliance | Description | Data |
|---|---|---|---|---|---|
| | | | Yes | Surface Condition? (G/P) | Good |
